**GOLDER REPORT TO MINISTRY OF ENVIRONMENT
AUGUST 1979**

The information contained in this appendix should be reviewed in conjunction with the main body of the report entitled “Geotechnical Seismic Vulnerability Assessment of Fraser River Escarpment, Maple Ridge, B.C.”, dated March 23, 2004. Golder Associates Ltd. cannot be responsible for use by any party of this information without reference to the entire report. Unless otherwise stated, the suggestions, recommendations and opinions given herein are intended only for the guidance of the Client at the time of writing of the document and are not applicable to any other project or site location. Furthermore, the extent and detail of the factual information contained herein was intended for consideration of regional subsurface conditions and the potential for landslides occurring along the Fraser River Escarpment. Any person(s) wishing to assess the potential impacts of landslide events on any specific property should rely on their own investigations and their own interpretations of the factual data presented herein.

COVERING LETTER
TO
MINISTRY OF ENVIRONMENT
WATER INVESTIGATIONS BRANCH
ON
STABILITY STUDY
FRASER RIVER NORTH RIVER B

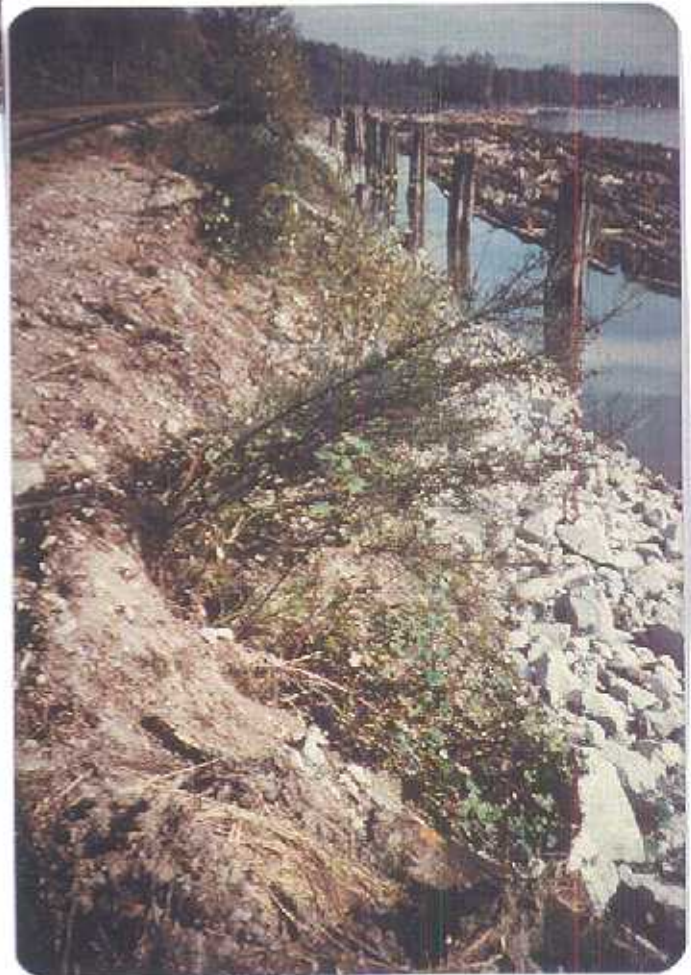
Photo 4: Rip-rap protection. Note area where rip-rap has slumped into river, indicating ongoing undercutting and erosion in river.

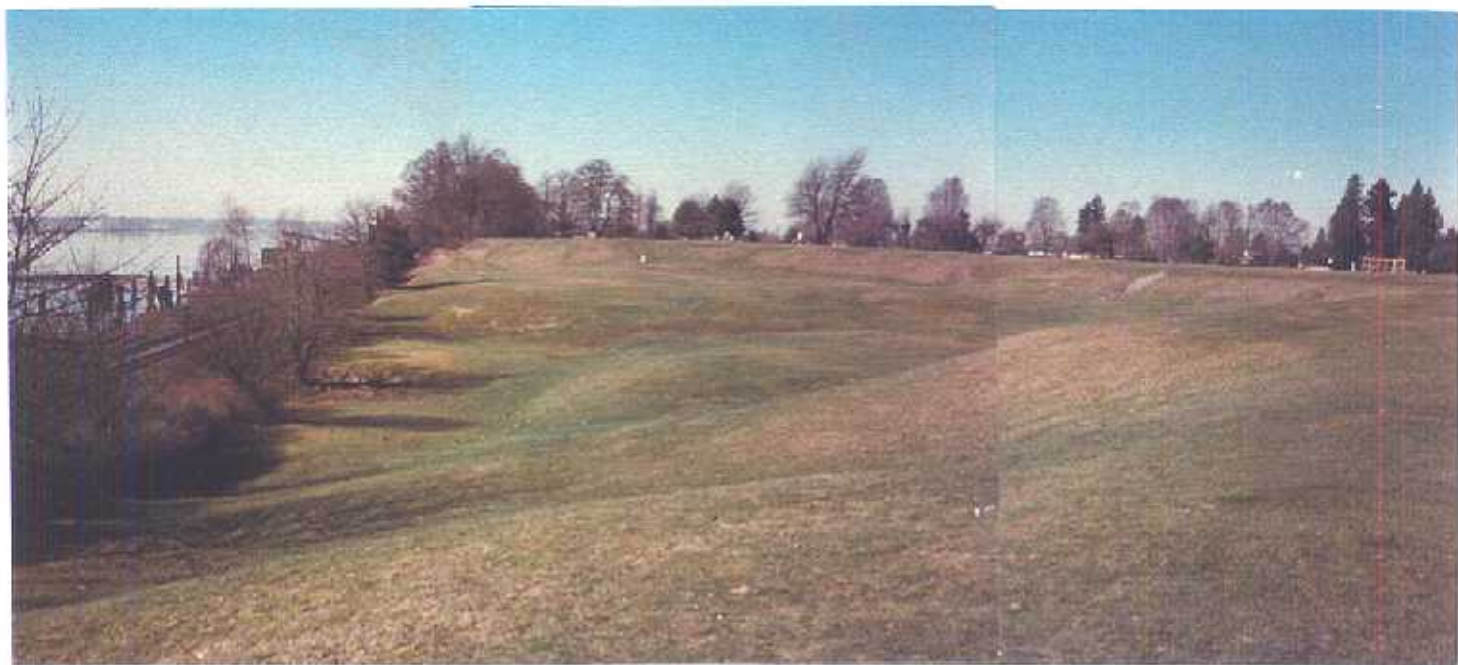
surface geometries for these slides are determined by the present topography, and the previous slope geometries can be inferred from the existing slopes either side of the failures (see Figure 6 - Section 26, and Photos 5 and 7). The slopes must, by definition, have had factors of safety of less than or equal to 1.0 at failure.

The back analysis of the minor Port Hammond slide indicates that substantial piezometric pressures would be required to cause failure, i.e. about 10 m above the slope crest. Alternatively, a completely saturated slope combined with the design earthquake would result in a low factor of safety. It is possible that the failure may have taken place when the river channel was significantly deeper, so that the assumed preslide geometry may be incorrect.

Photo 5: Minor Port Hammond Slide. Note slide backscarp and hummocky slide debris terrain. Area is developed as a golf course.

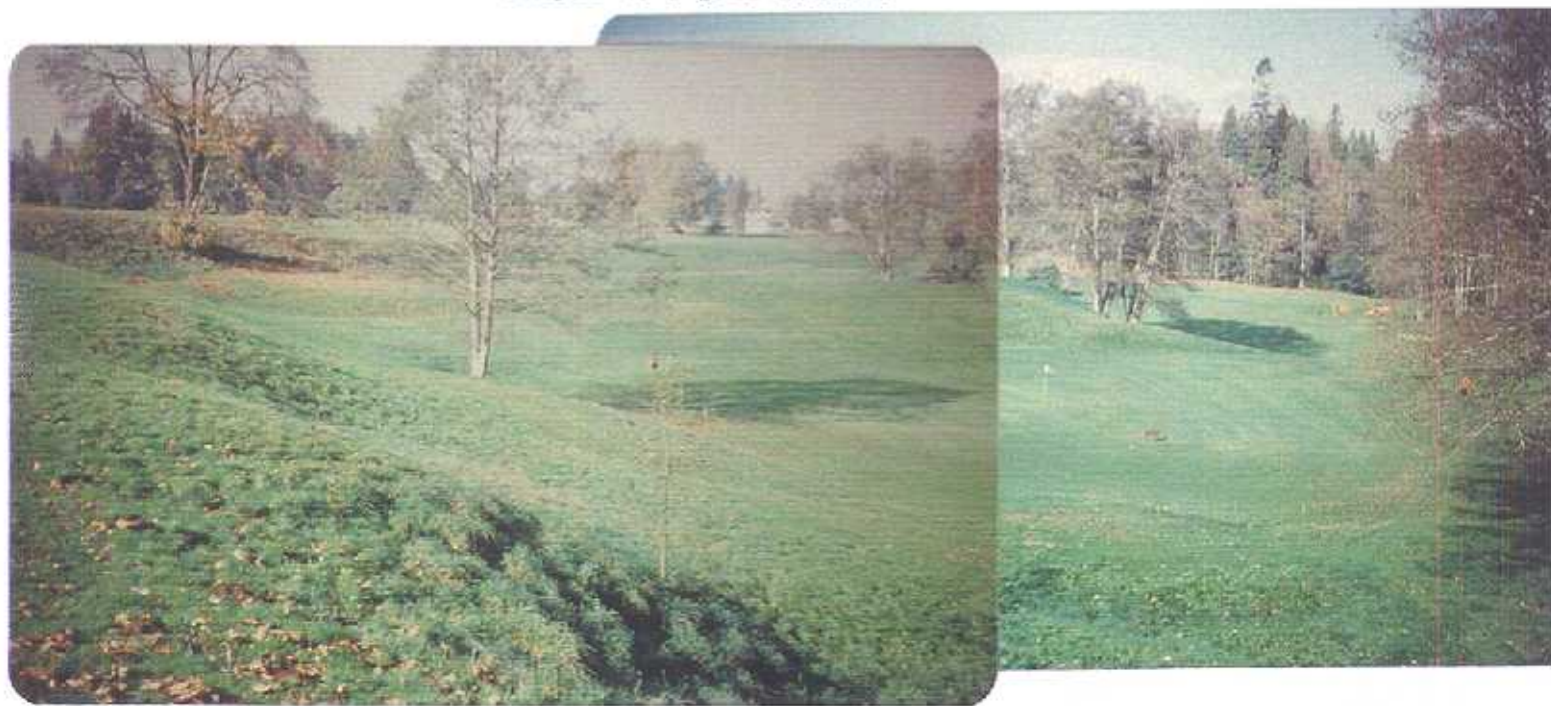
The age of the Port Hammond landslide is not known. Based on the trees present in the slide area and the absence of slide debris at the toe of the failure, it is likely that the slide occurred at least 200 years ago. The retrogressive nature of this slide is confirmed by the scarps at

the west side of the slide, which are aligned perpendicular to the river (Photo 6). These represent smaller slides which failed laterally into the main body of the slide, resulting in a lateral expansion of the failure area.

Photo 6: Major Port Hammond slide, view to the north, i.e. into the slide. Major backscarp concealed by tree cover in background. Note on left, backscarps of subsidiary slides which occurred laterally into main body of slide.

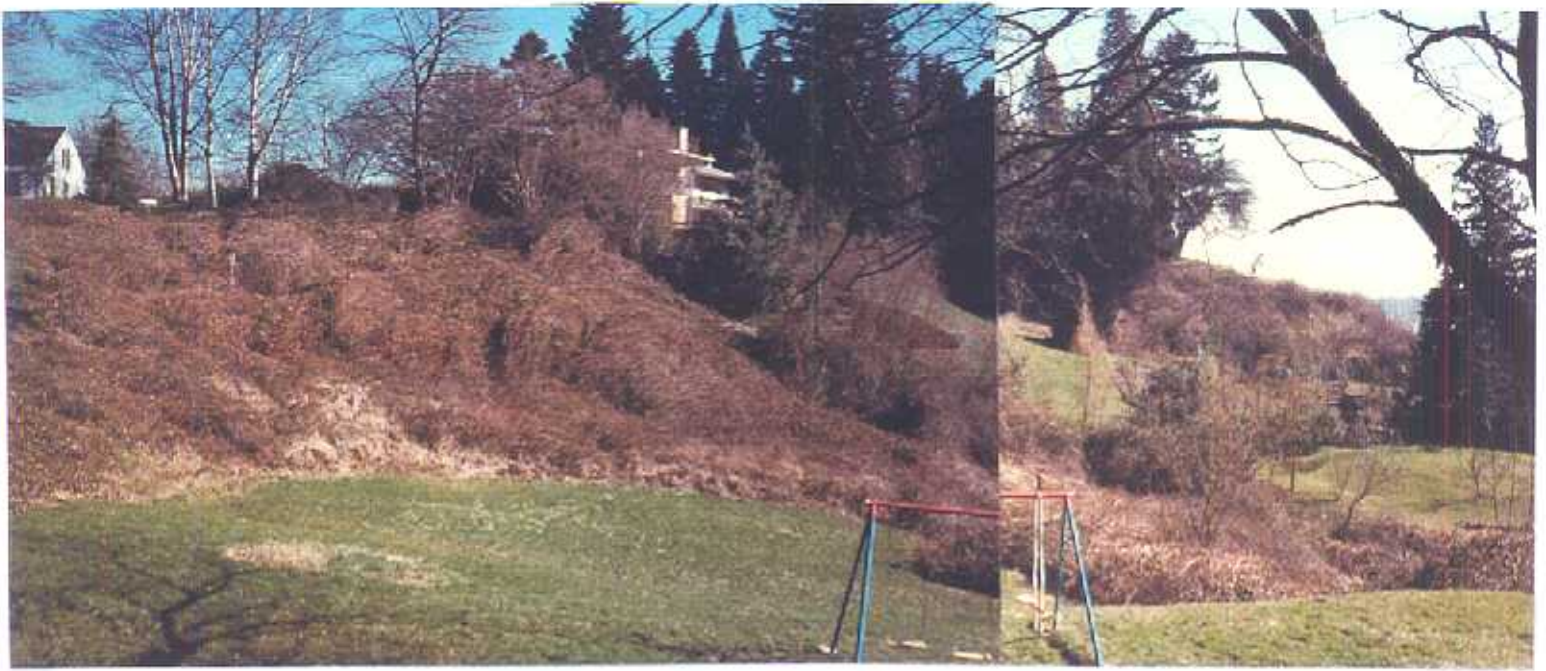
The back analysis of the Fir Street slide shows that a completely saturated slope would have resulted in a reduction of the factor of safety to about 0.95 to 1.0. Alternatively, a design earthquake shock would also have resulted in failure. This gives good agreement with the estimated present factors of safety for the adjacent slopes.

Photo 7: Fir Street Slide. Note hummocky slide debris terrain and existing development.

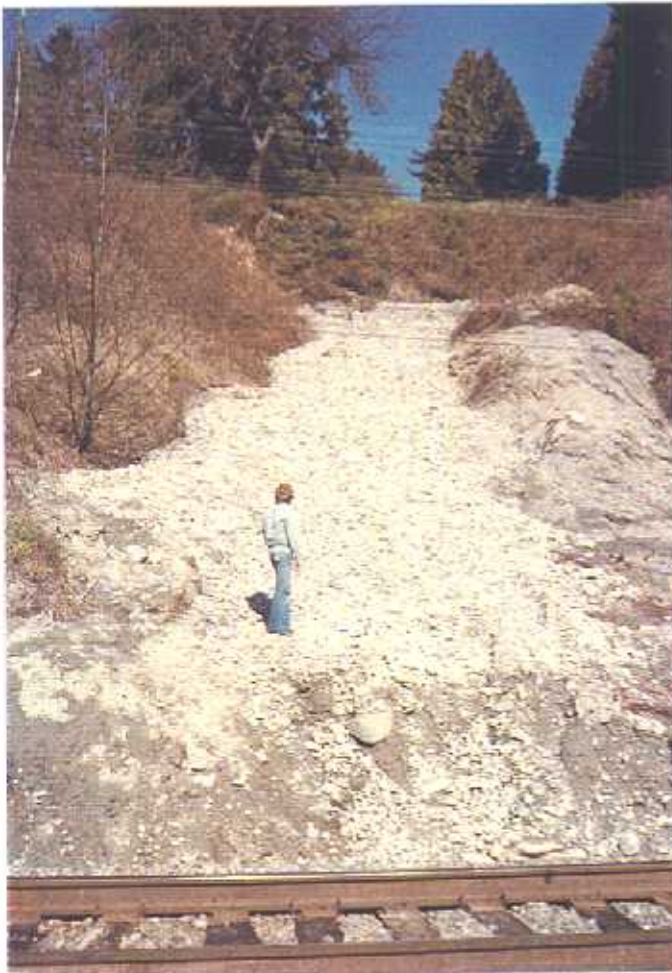
These failures frequently cause movements close to the railway tracks. The CPR has undertaken a program of maintenance, consisting mainly of drainage to stabilize shallow failures on the slope. Ongoing work is being performed at Mile 103.5 (Section 11) and at Mile 103.9 (Section 16 - Photo 8).

Photo 8: Drainage stabilization of surficial slide on upper slope above CPR, at approx. Section 16 (CPR Mile 103.9). Drainage consists of perforated pipes installed in gravel backfilled trench.

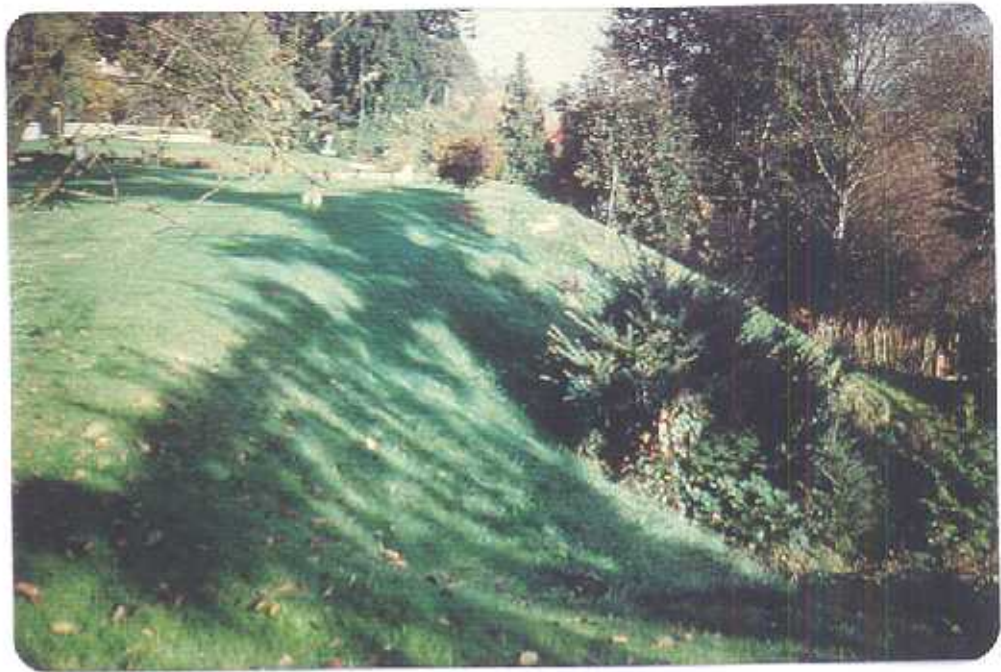
Minor surficial failures are frequently observed along the upper slope above the CPR bench. These failures take the form of shallow flow slides of clay and sand materials, and are generally associated with seepage zones exiting in sand layers on the slope face. Shallow back scarps have been formed at the upper slope crest (see Photos 9 and 10).

Photos 9 and 10: Surficial slides
at crest of upper slopes. Note
formation of backscarps.

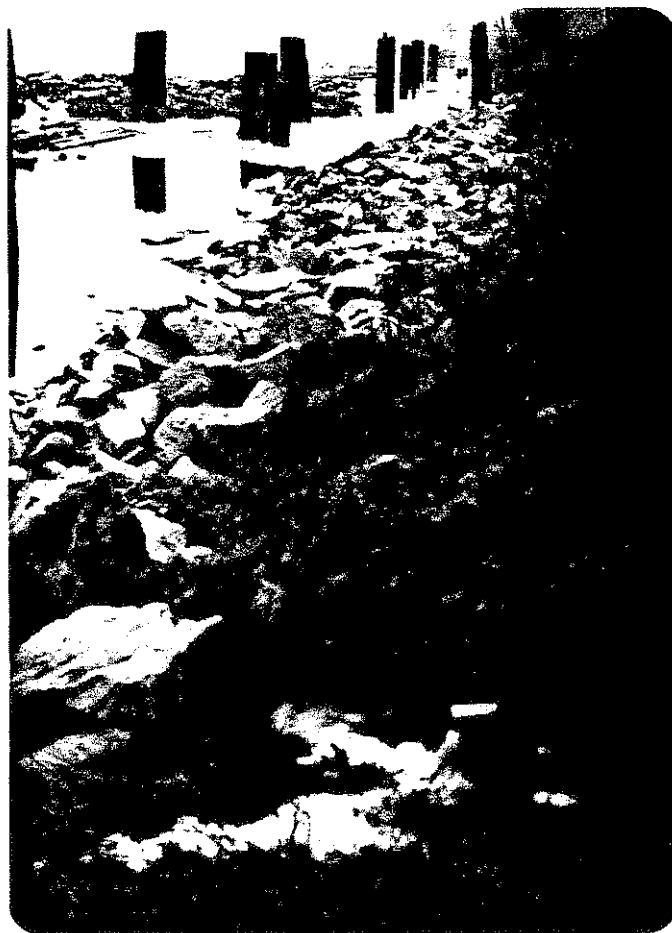
Photo 1. View upstream towards Port Hammond (mill in background). Note riprap which stops well below top of railway embankment. Location approximately Section 21. Also note extent of dolphins and piles along bank.

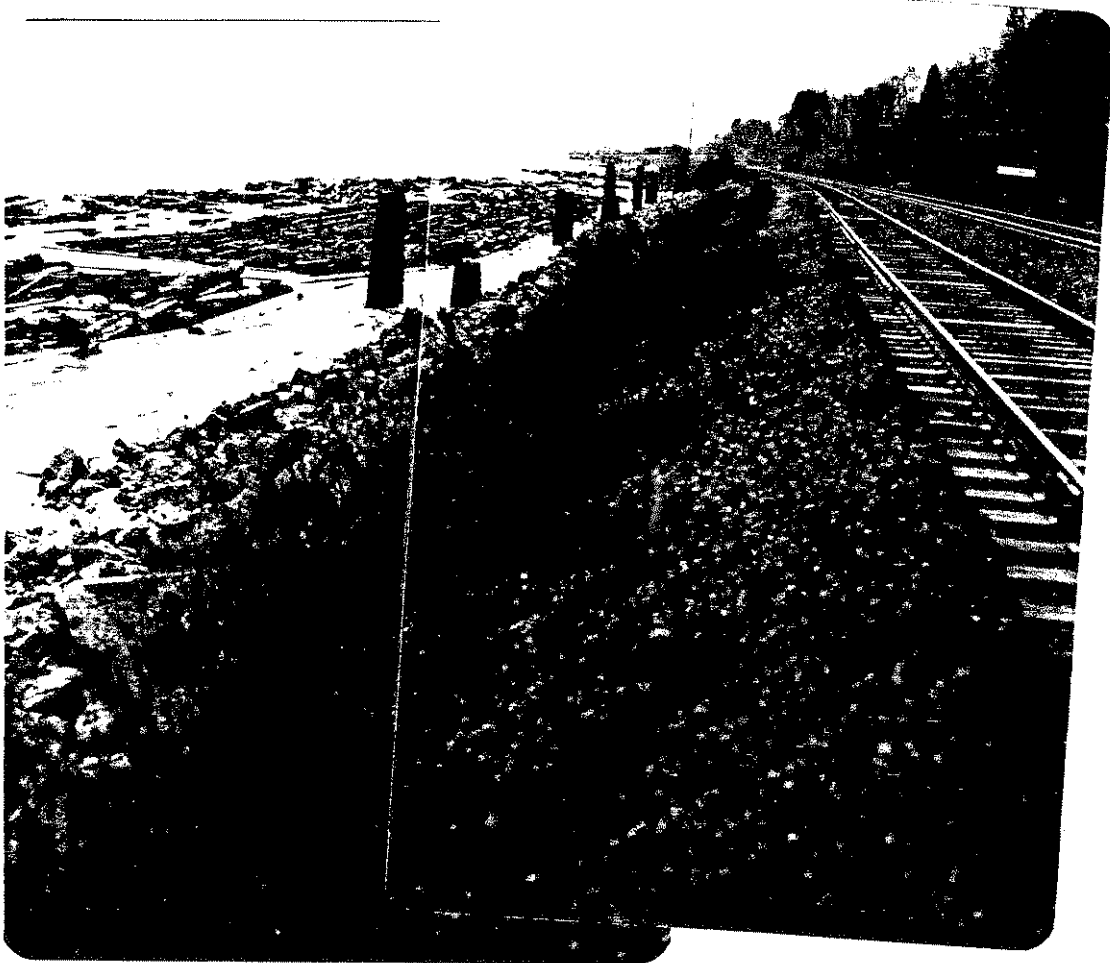
Photos 2 & 3. View downstream towards Port Hammond location approximately Section 19. Note riprap in foreground is well below railway grade, while a short segment is as high as the railway grade in the center background. Riprap in this area is relatively poorly graded, although the rock is of good quality.

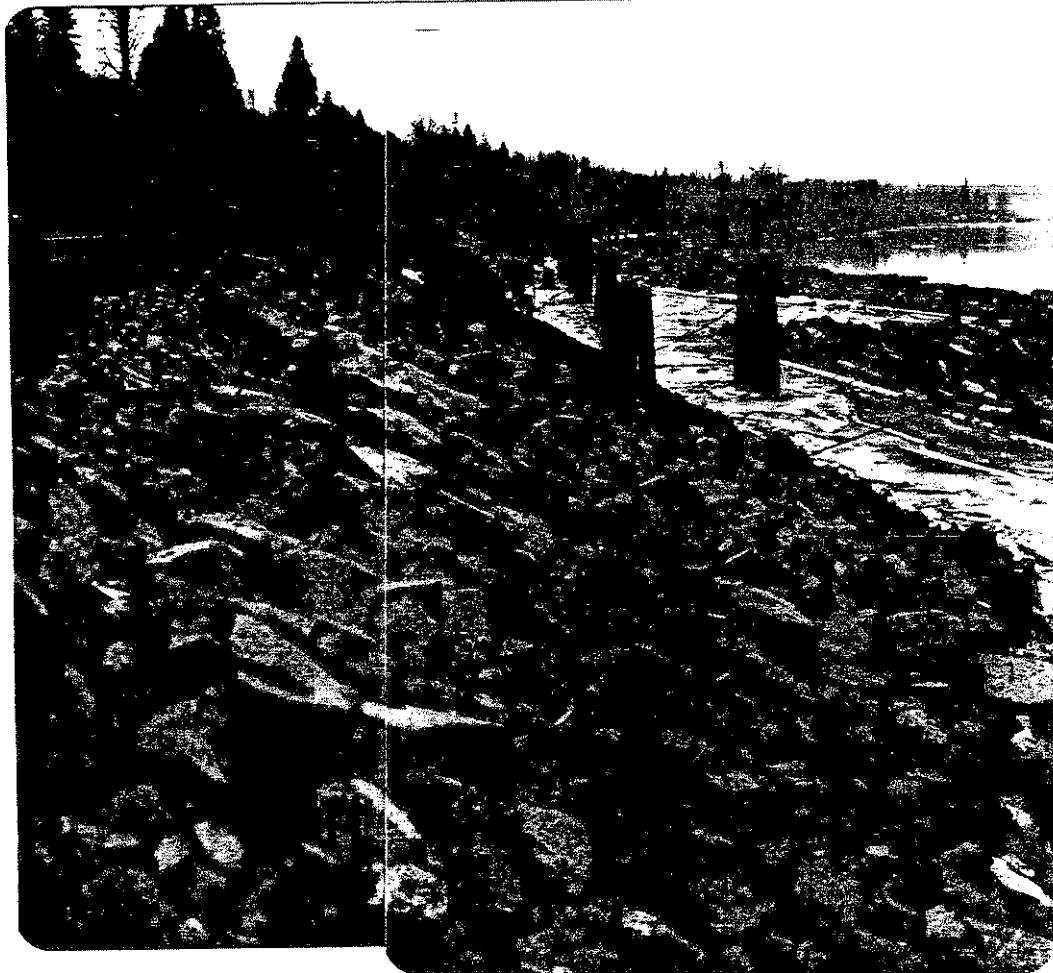
Photos 4 & 5. View upstream approximately from cross section 16. Riprap extends almost to railway grade at this point. This appears to be relatively newly placed rock. Note material deposited over riprap in centre of photo. Again note extent of dolphins and log booming. 1880 Slide is at centre background of photo.

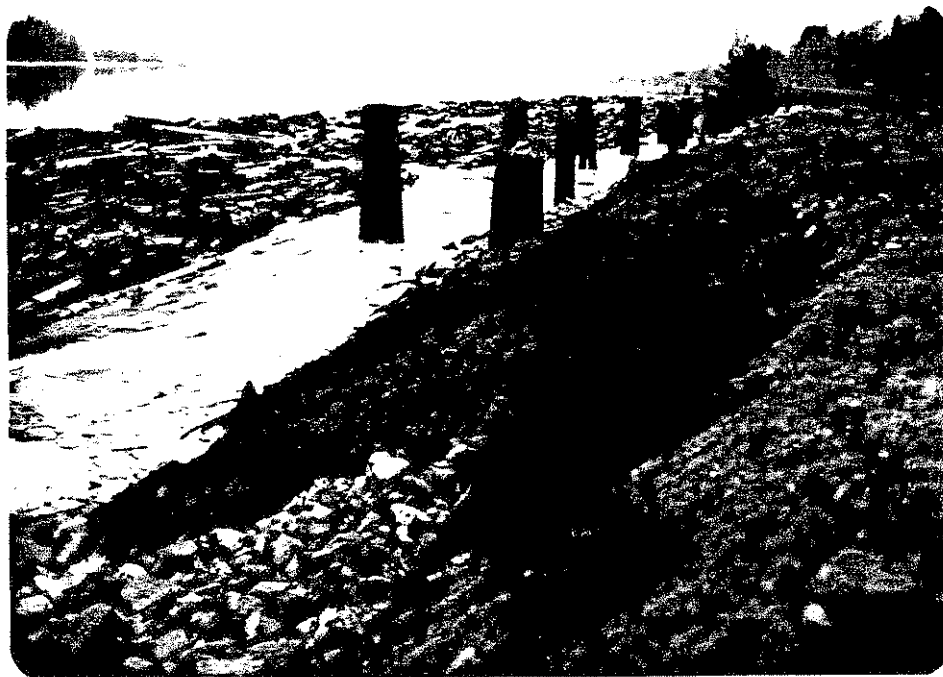
Photo 7. Assumed deposition from slide of photo 6. Note culvert exit in embankment at the right centre of photograph.

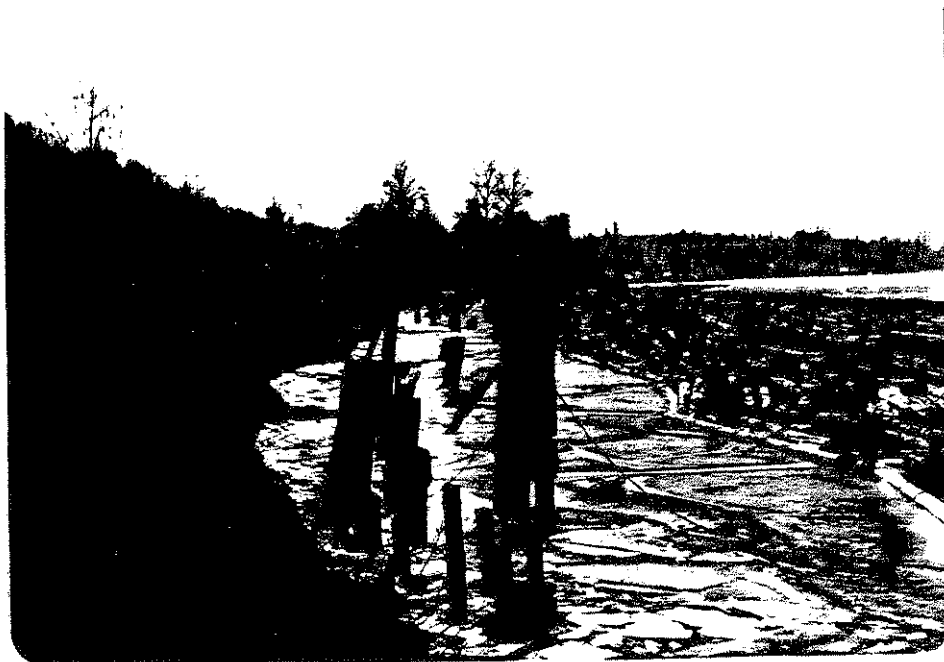
Photo 9. View upstream around Section 12. Between here and the 1880 slide, there has obviously been deposition as opposed to erosion. Photo taken from protruding culvert.

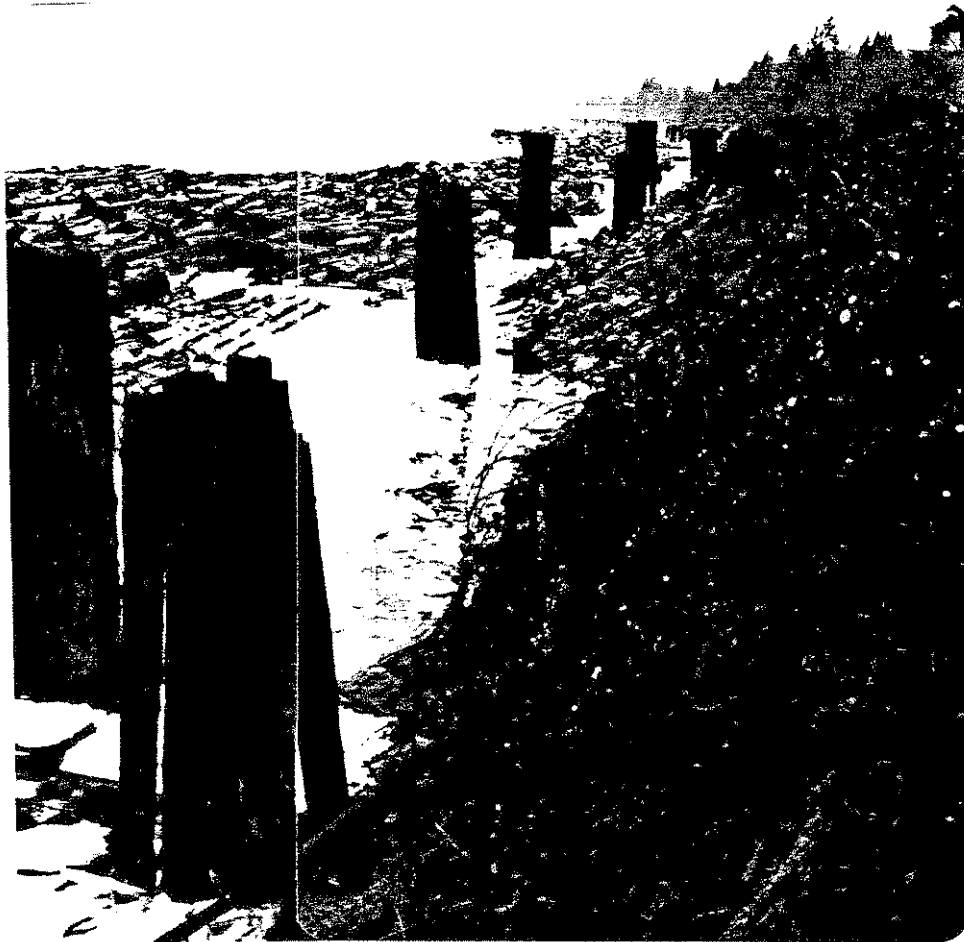
Photos 10 & 11. View downstream from the same location as photo 9. Note steeper natural bank and evidence of erosion in this area. There is a considerable amount of launched riprap visible at the waterline. Again note extent of dolphins and log booms.

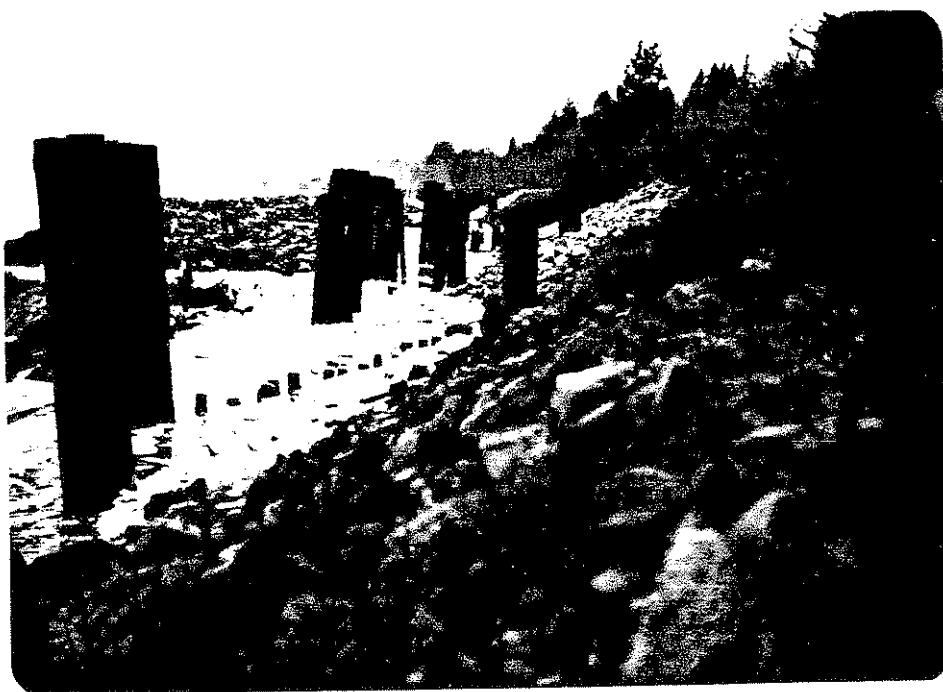
Photo 13. Another view upstream, a short distance upstream of photo 12. Riprap in this area has been placed for some time. Note old piles cut off above low water line at left. Also, looking upstream note intermittent placement of riprap.

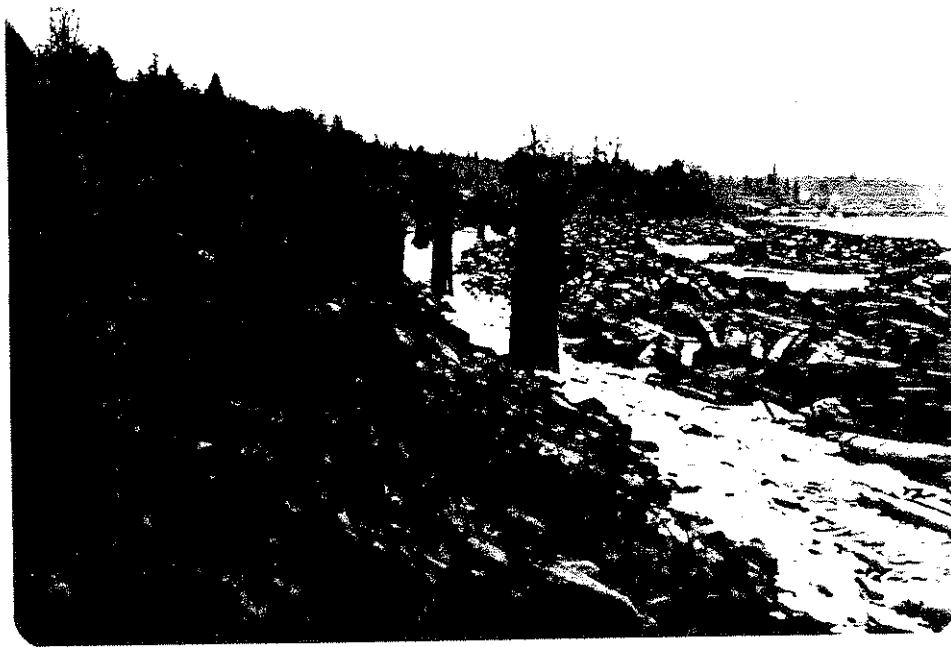
Photo 14. View upstream towards 1880 slide from same location as photo 13. Again note older riprap, which is overgrown with local vegetation, and has launched some distance into the river.
