**GOLDER REPORT TO MINISTRY OF ENVIRONMENT
JULY 1983**

REPORT TO
BRITISH COLUMBIA MINISTRY OF ENVIRONMENT
WATER INVESTIGATION BRANCH
ON
GROUND WATER MONITORING AND
STABILIZATION STUDY
FRASER RIVER NORTH RIVER BANK
MAPLE RIDGE, BRITISH COLUMBIA

July, 1983

822-1071

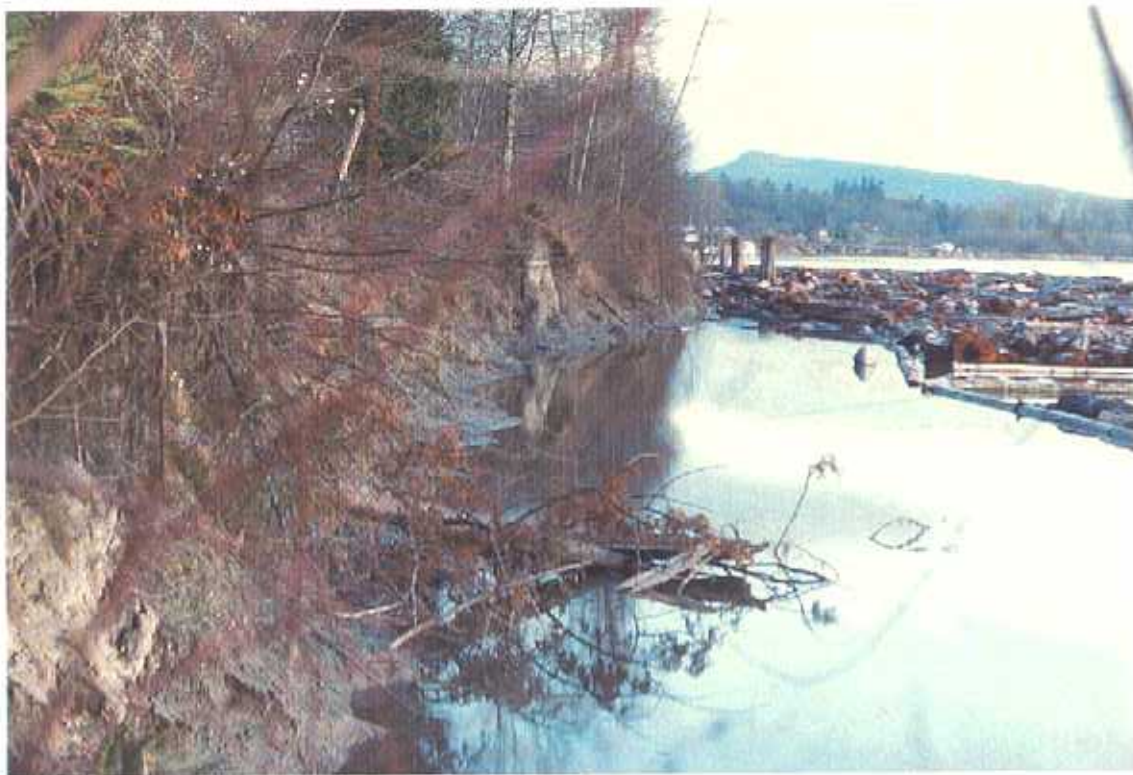
PHOTO 1

Comparative view upstream from downstream end of
1880 slide - from approx. Ministry cross section no. 8.
Note the position of trees at centre background is
the same in both photos.

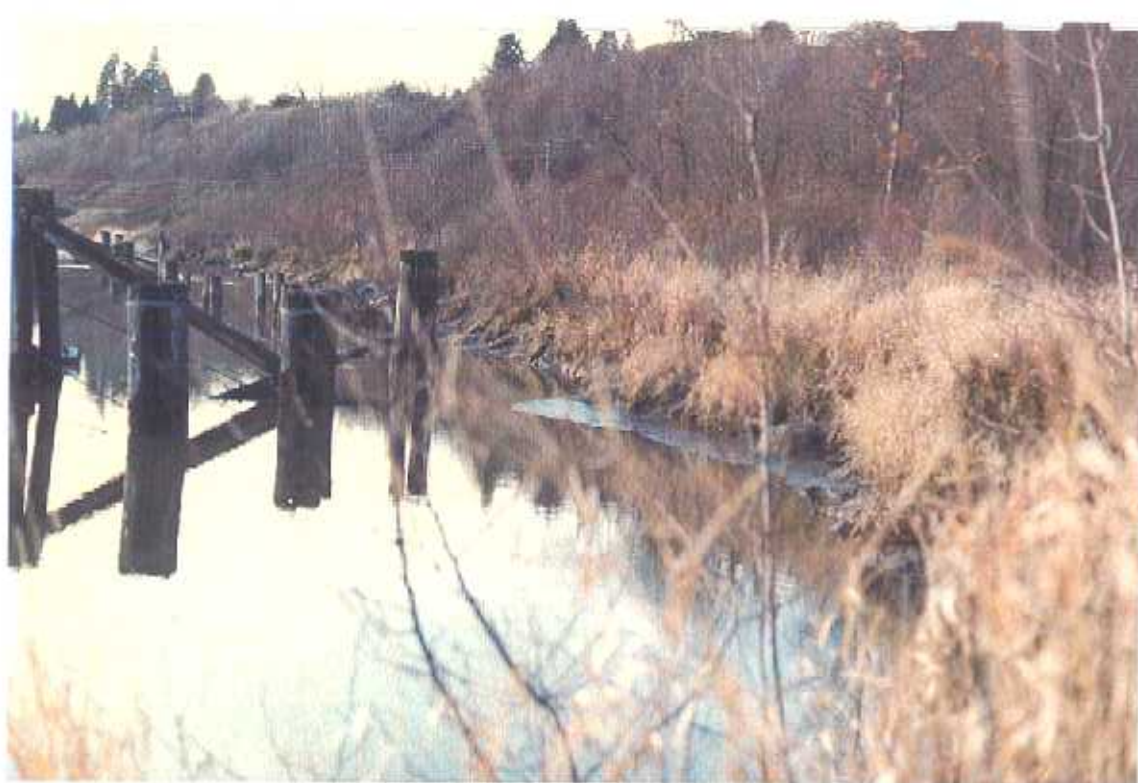
PHOTO 3

Comparative views upstream taken from about Ministry cross section no. 8. Almost no erosion has taken place above the water line.

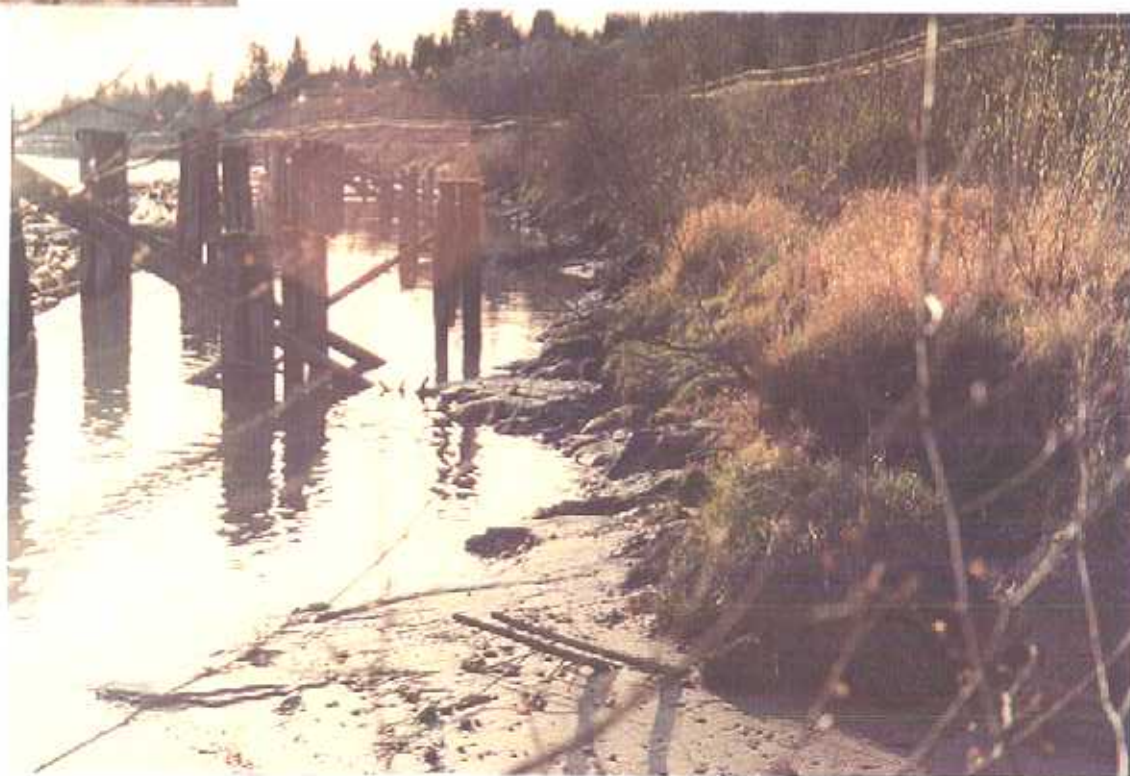
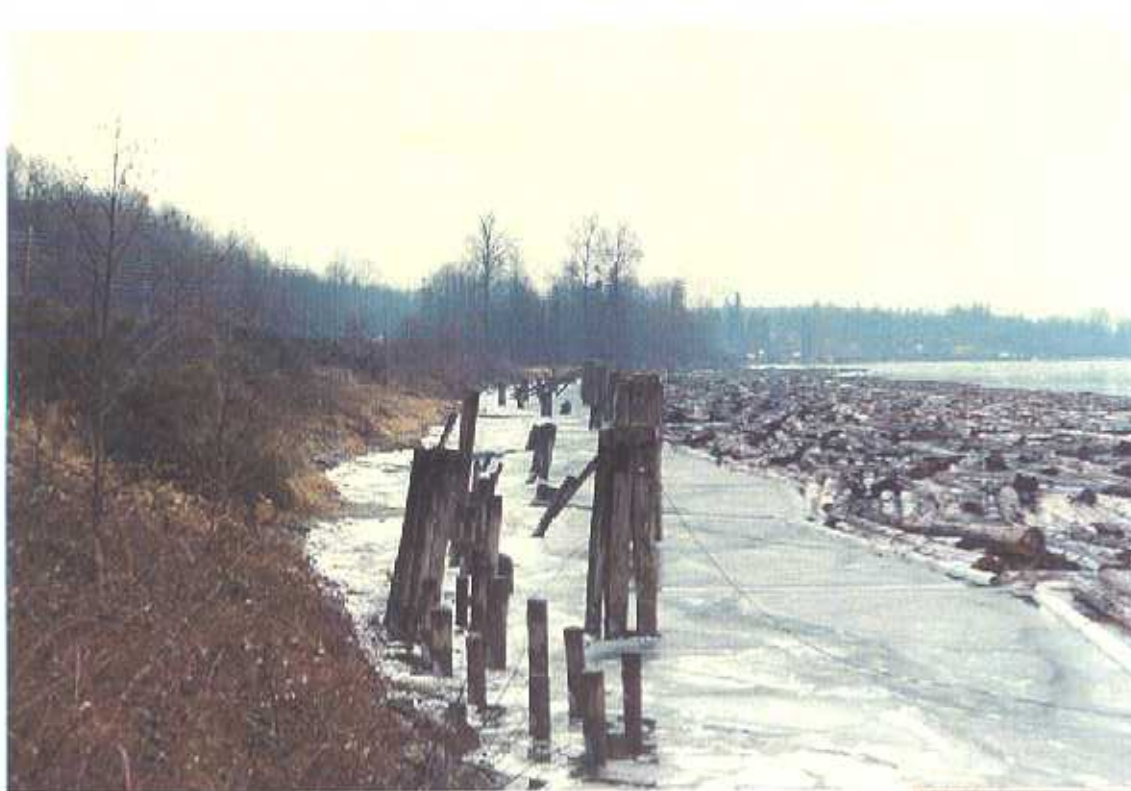
PHOTO 5

View upstream near Ministry cross section no. 12. Position of piles relative to bank is similar in each photo.

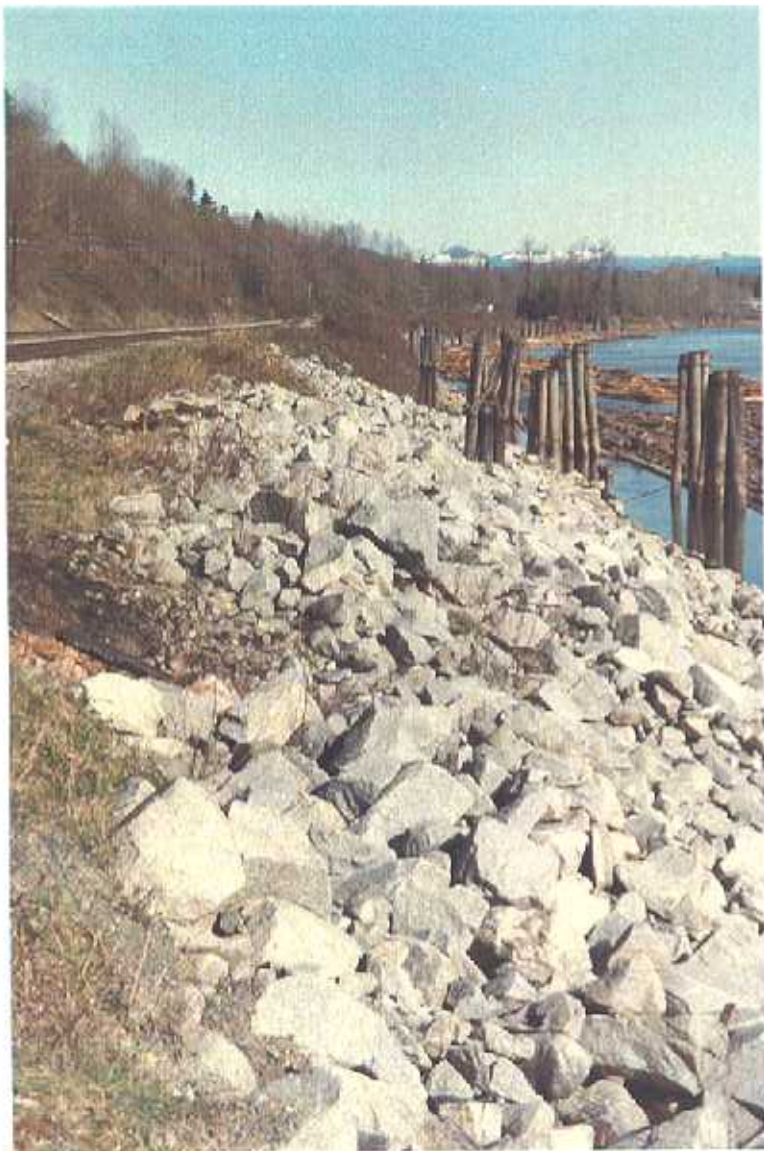
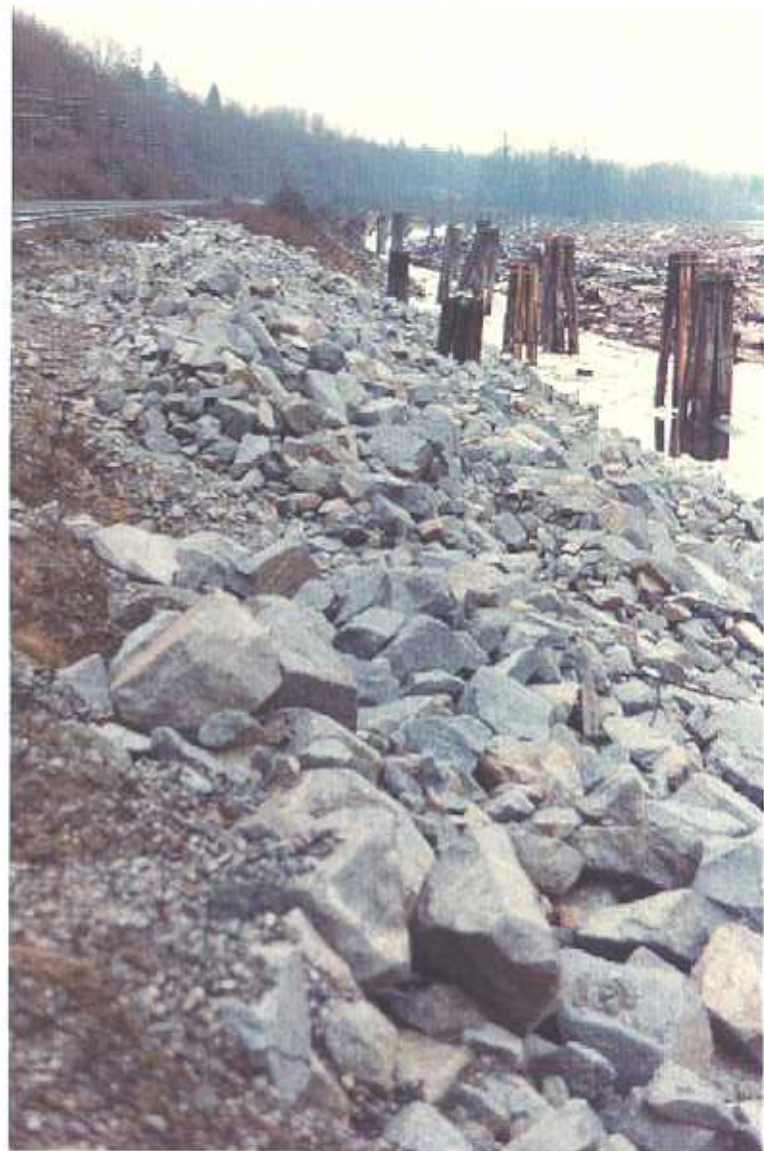
PHOTO 8

Comparative view upstream from about Ministry cross section No. 14
Note that most of the riprap is in the same position in both photos.

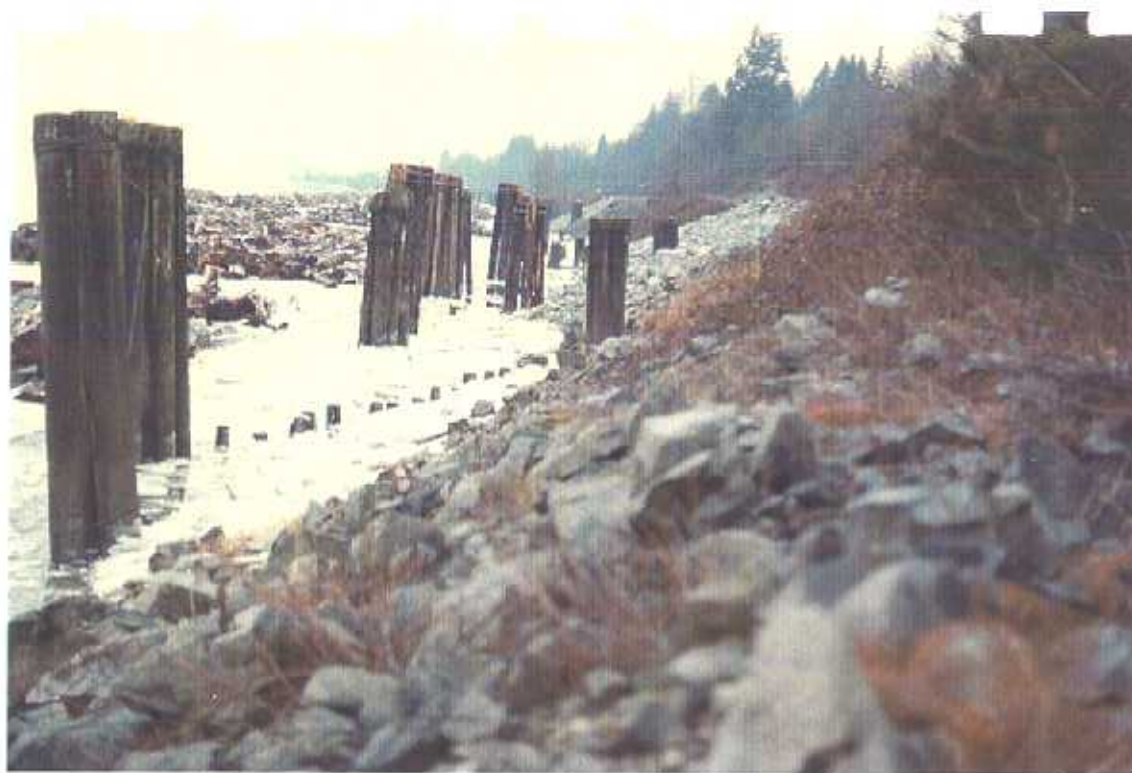
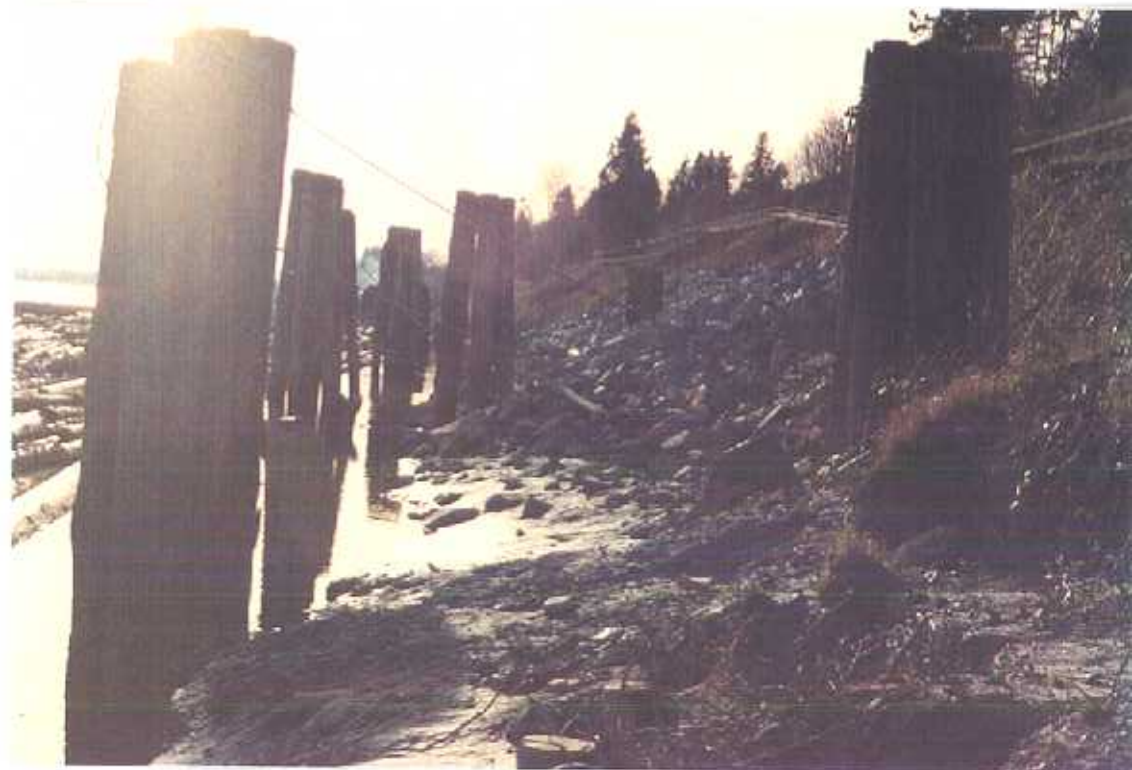
PHOTO 10

View downstream from approximately Ministry cross section no. 19. Cut off timber piles at centre of Photo 9 (in ice) are the same ones seen in centre foreground of Photo 10. Again there is little evidence of erosion above the water line.

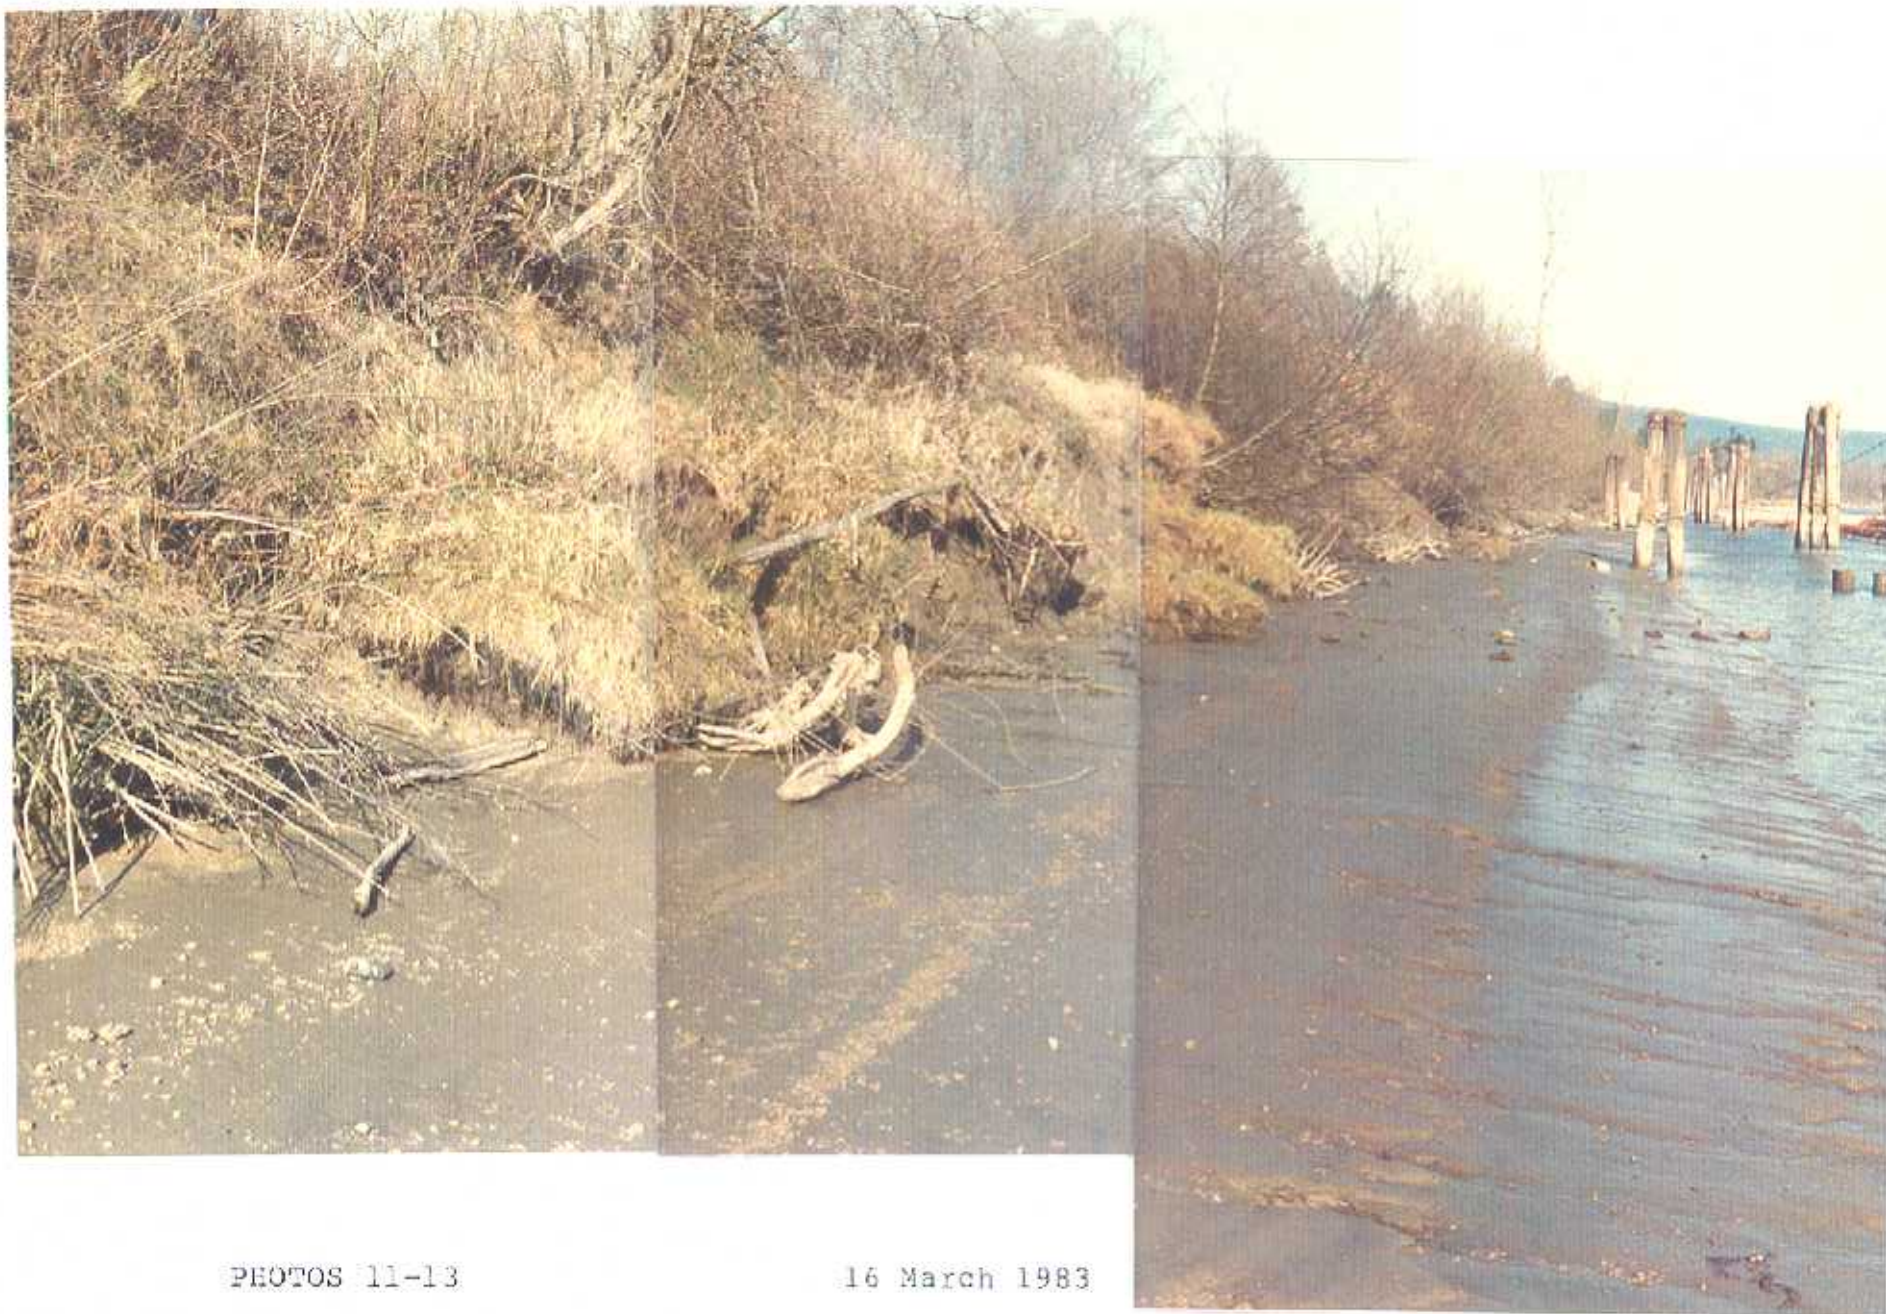
PHOTOS 11-13

View upstream at approximately Ministry cross section no. 23. Above the water line, there is some minor erosion/slumping of the toe on the steep bank at left. Note the beach area typical of this downstream reach.
