**GOLDER REPORT TO MINISTRY OF ENVIRONMENT
MARCH 1986**

REPORT
TO
BRITISH COLUMBIA
MINISTRY OF ENVIRONMENT
ON
FRASER RIVER BANK STABILITY
MAPLE RIDGE, BRITISH COLUMBIA

March, 1986

862-1906

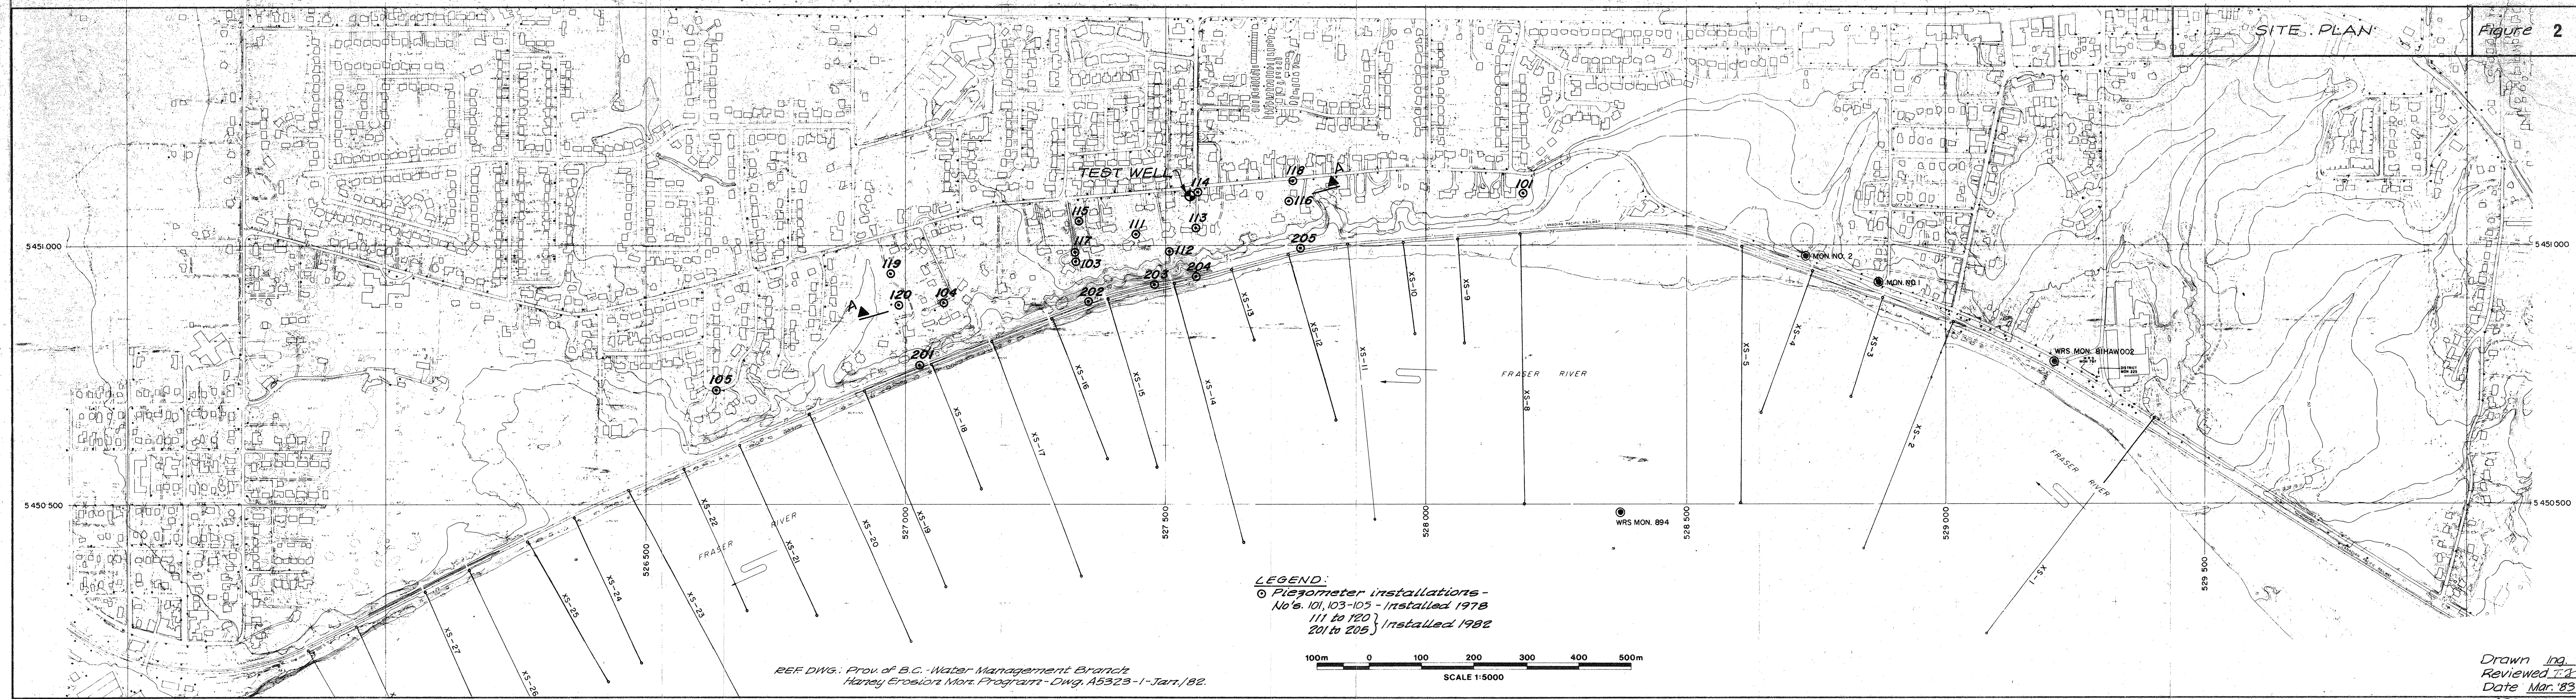
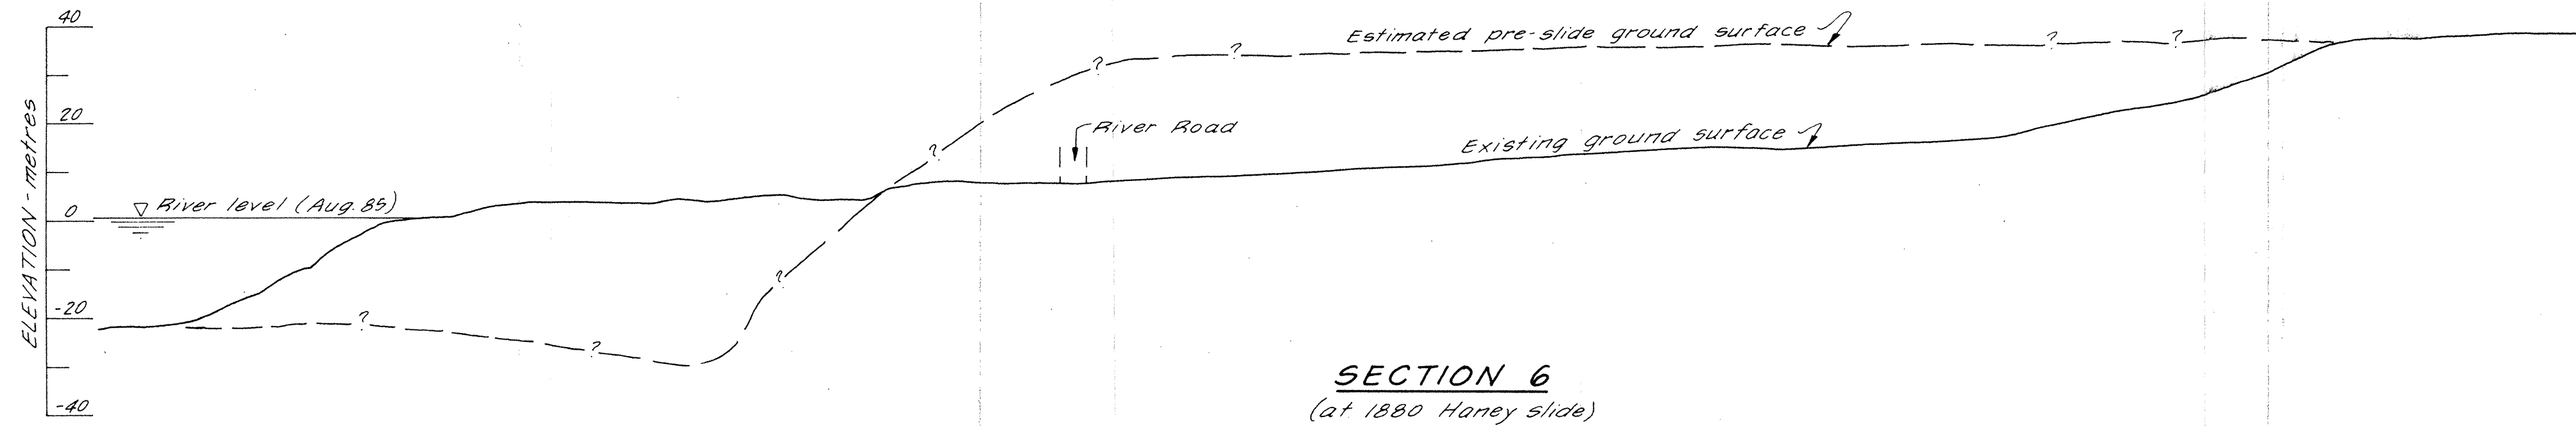
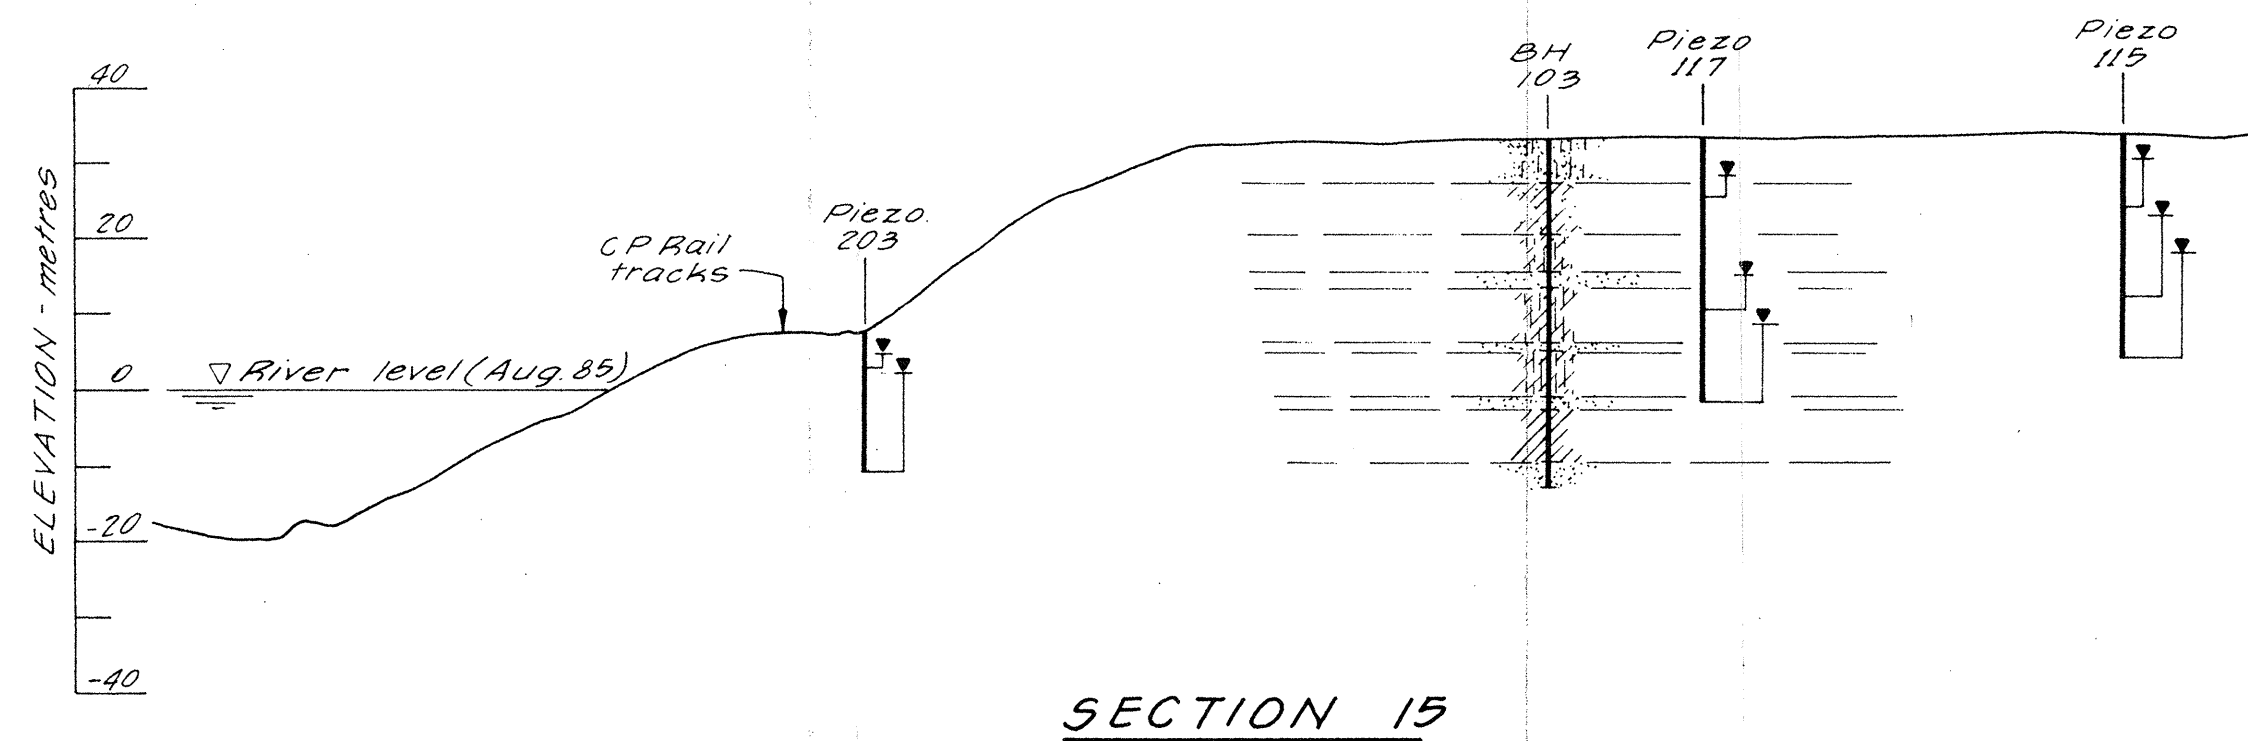
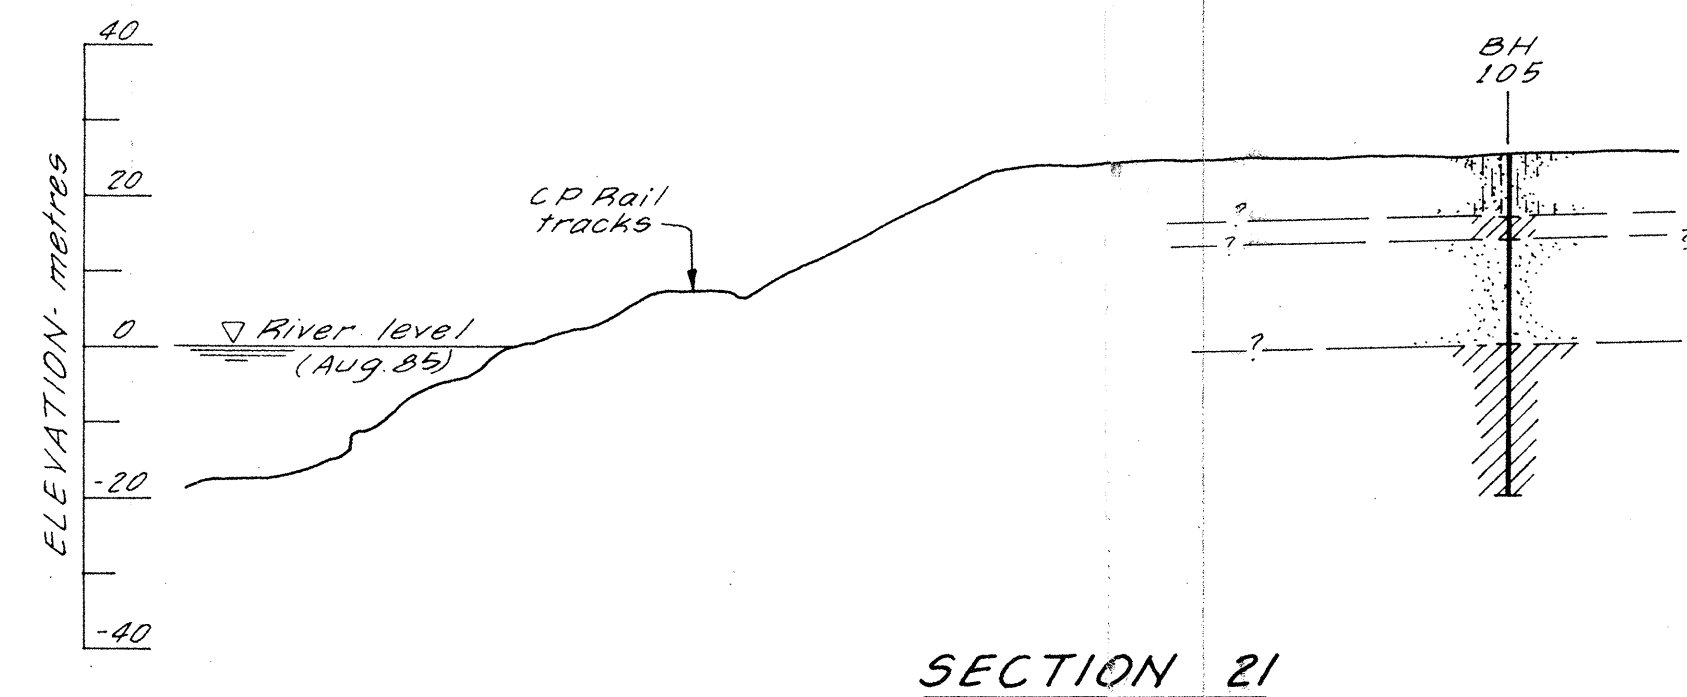
- o The piezometric pressures in the area underlying the uplands and slopes are considerably lower than the hydrostatic pressure. Piezometric level fluctuations of up to 1 and 2.5 metres have been observed in deeper and shallower piezometers, respectively. These fluctuations appear to be in response to seasonal precipitation.
- o The piezometric pressures beneath the C.P. Rail bench increase hydrostatically with depth. Fluctuations of up to 2.3 metres have been observed. The piezometric levels are controlled by C.P. Rail drainage measures, river levels, and precipitation.
- o Since there have been several periods of heavy precipitation and snow melt during the monitoring period of the past few years it is concluded that the range of piezometric levels is unlikely to vary significantly from that recorded to date.

Under present conditions we estimate that the most critical factor of safety against a major deep-seated failure under static conditions is between 1.2 and 1.4, depending on the assumed shear strength and piezometric pressures. The factor of safety could be reduced under earthquake loading, by varying the piezometric pressure, or by river erosion.

15 m at the toe of the slope would reduce the factor of safety by about 10 per cent, to levels of concern.

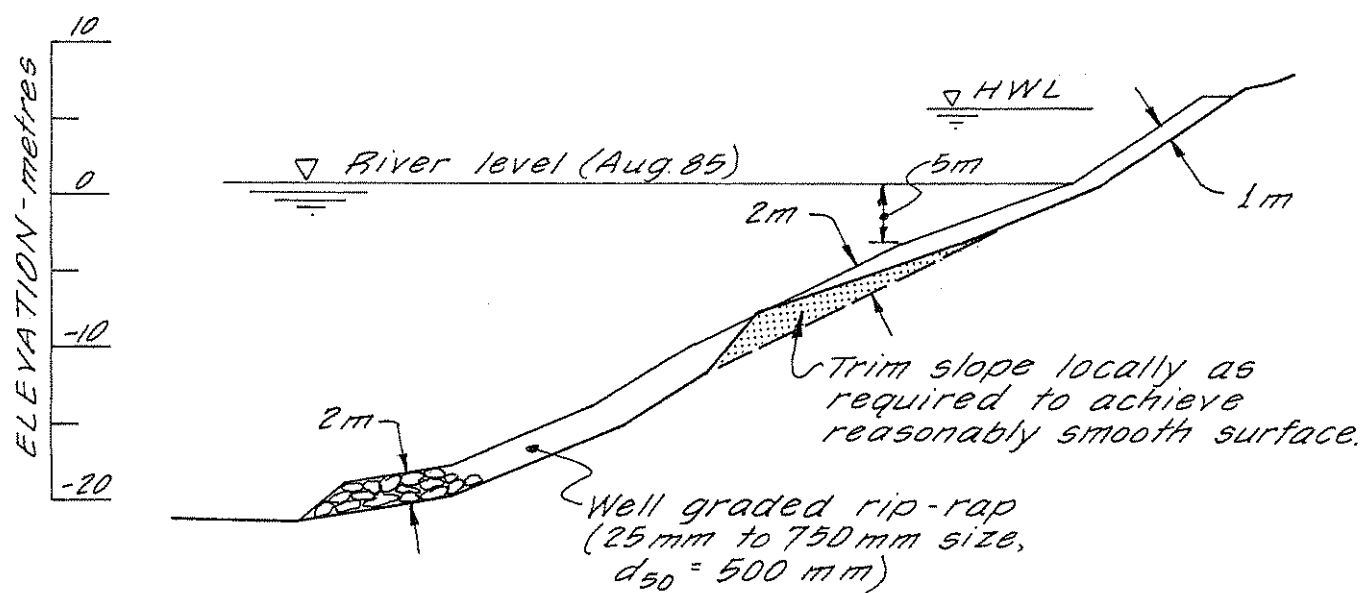
SECTION 12 (1985)

A typical cross section of the tentative rip rap treatment is given on Figure 4. The tentative rip rap thickness is shown as 2 m to accommodate construction techniques. The use of filter cloth or a well graded quarry tailings filter is considered desirable but difficult to employ. The design of the erosion protection may be modified during final design to accommodate a two-layer system.

The proposed rip rap consists of a well graded rock ranging in size from 25 mm to 750 mm. The rock would be placed by clam from a scow. If employed, the underlying granular filter layer could consist of quarry tailings, or a synthetic filter if special design and construction techniques were used.

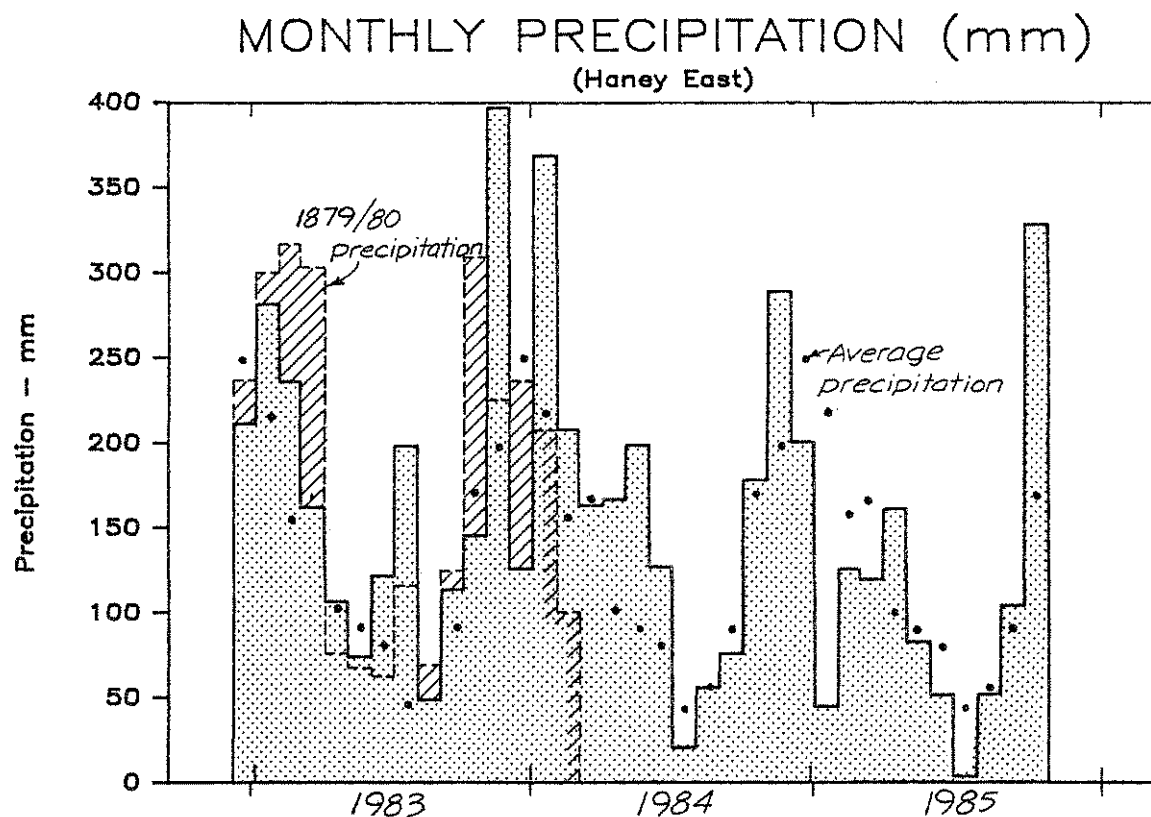
A review of meteorological data indicates that the precipitation during the current study period was as adverse as that experienced during 1879 to 1880, and is periodically more severe than average conditions (see Appendix B). Severe total monthly precipitation was experienced during November 1983, January 1984 and October 1985. Severe cold weather was experienced during November 1985. Based on this information, an evaluation of the piezometric data indicates that ground water levels do not vary significantly with variable meteorological conditions.

Yearly Total	Total (Oct. to Jan.)
1879	2199.1	980.9
1983	2012.2	1037.6
Average	1630.7	839.7
