**FINAL REPORT ON**

**GEOTECHNICAL  
SEISMIC VULNERABILITY ASSESSMENT  
OF FRASER RIVER ESCARPMENT  
MAPLE RIDGE, B.C.**

Submitted to:  
District of Maple Ridge  
11995 Haney Place  
Maple Ridge, BC  
V2X 6A9

March 23, 2004  
03-1411-018

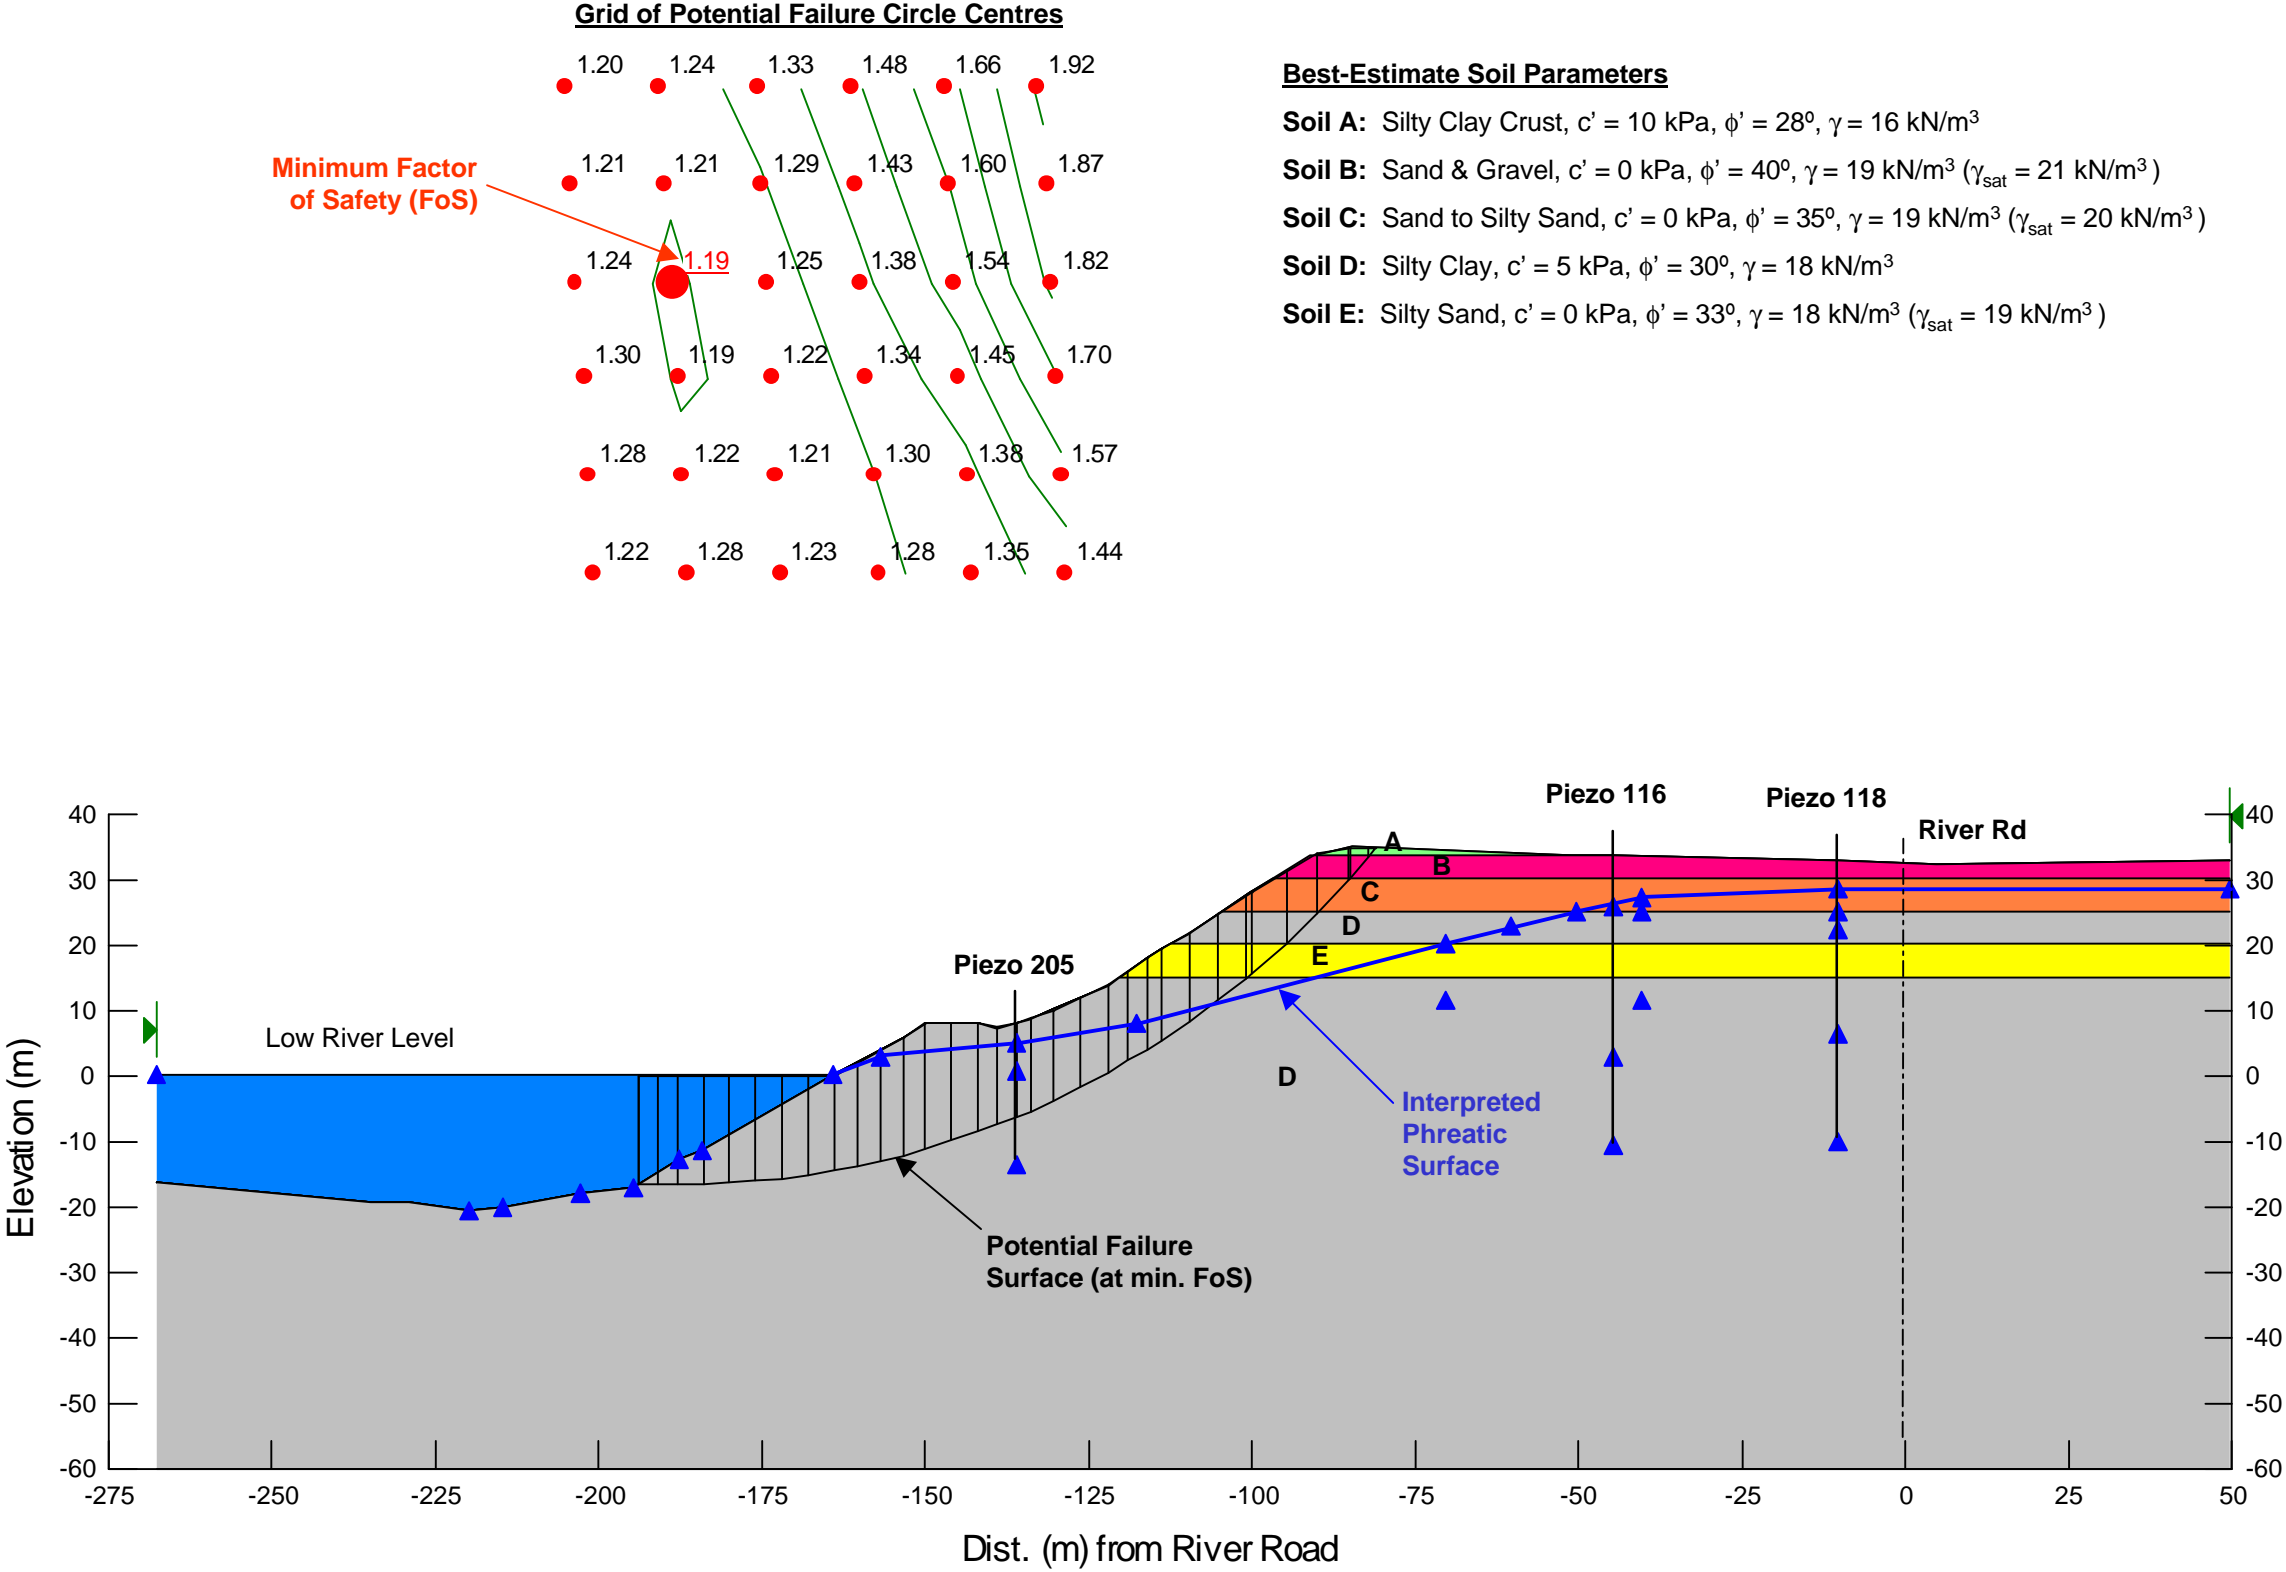
<b>Static Stability Analysis Section A-A</b>	
Drawn: CNW	App'd:	Date: June 20, 2003	Figure: <b>3a</b>
Project No.: 03-1411-018		Revision No.:

The minimum FoS under static conditions for potential deep-seated failure surfaces that exit the slope below the CP Rail bench and extend at least 10 m back from the crest of the bluffs were computed using “best-estimate” soil strengths, as well as high strength and low strength estimates corresponding to expected upper and lower bounds. These critical failure surfaces, along with best-estimate soil parameters and assumed phreatic surface, for Sections A-A, B-B and C-C are presented on Figures 3a, 3b and 3c, respectively.

The minimum FoS for deep-seated failures that would extend at least 10 m back from the crest of the bluffs are summarized in Table 4. Using best-estimate strength parameters, the minimum FoS is about 1.2 to 1.3, which indicates that the slopes are only marginally stable under static conditions. If the FoS were to drop below 1.1 (due to increased groundwater levels for example), some slope deformation could be anticipated. The static FoS for failures extending further back from the crest of slope increases with increasing distance from the crest.

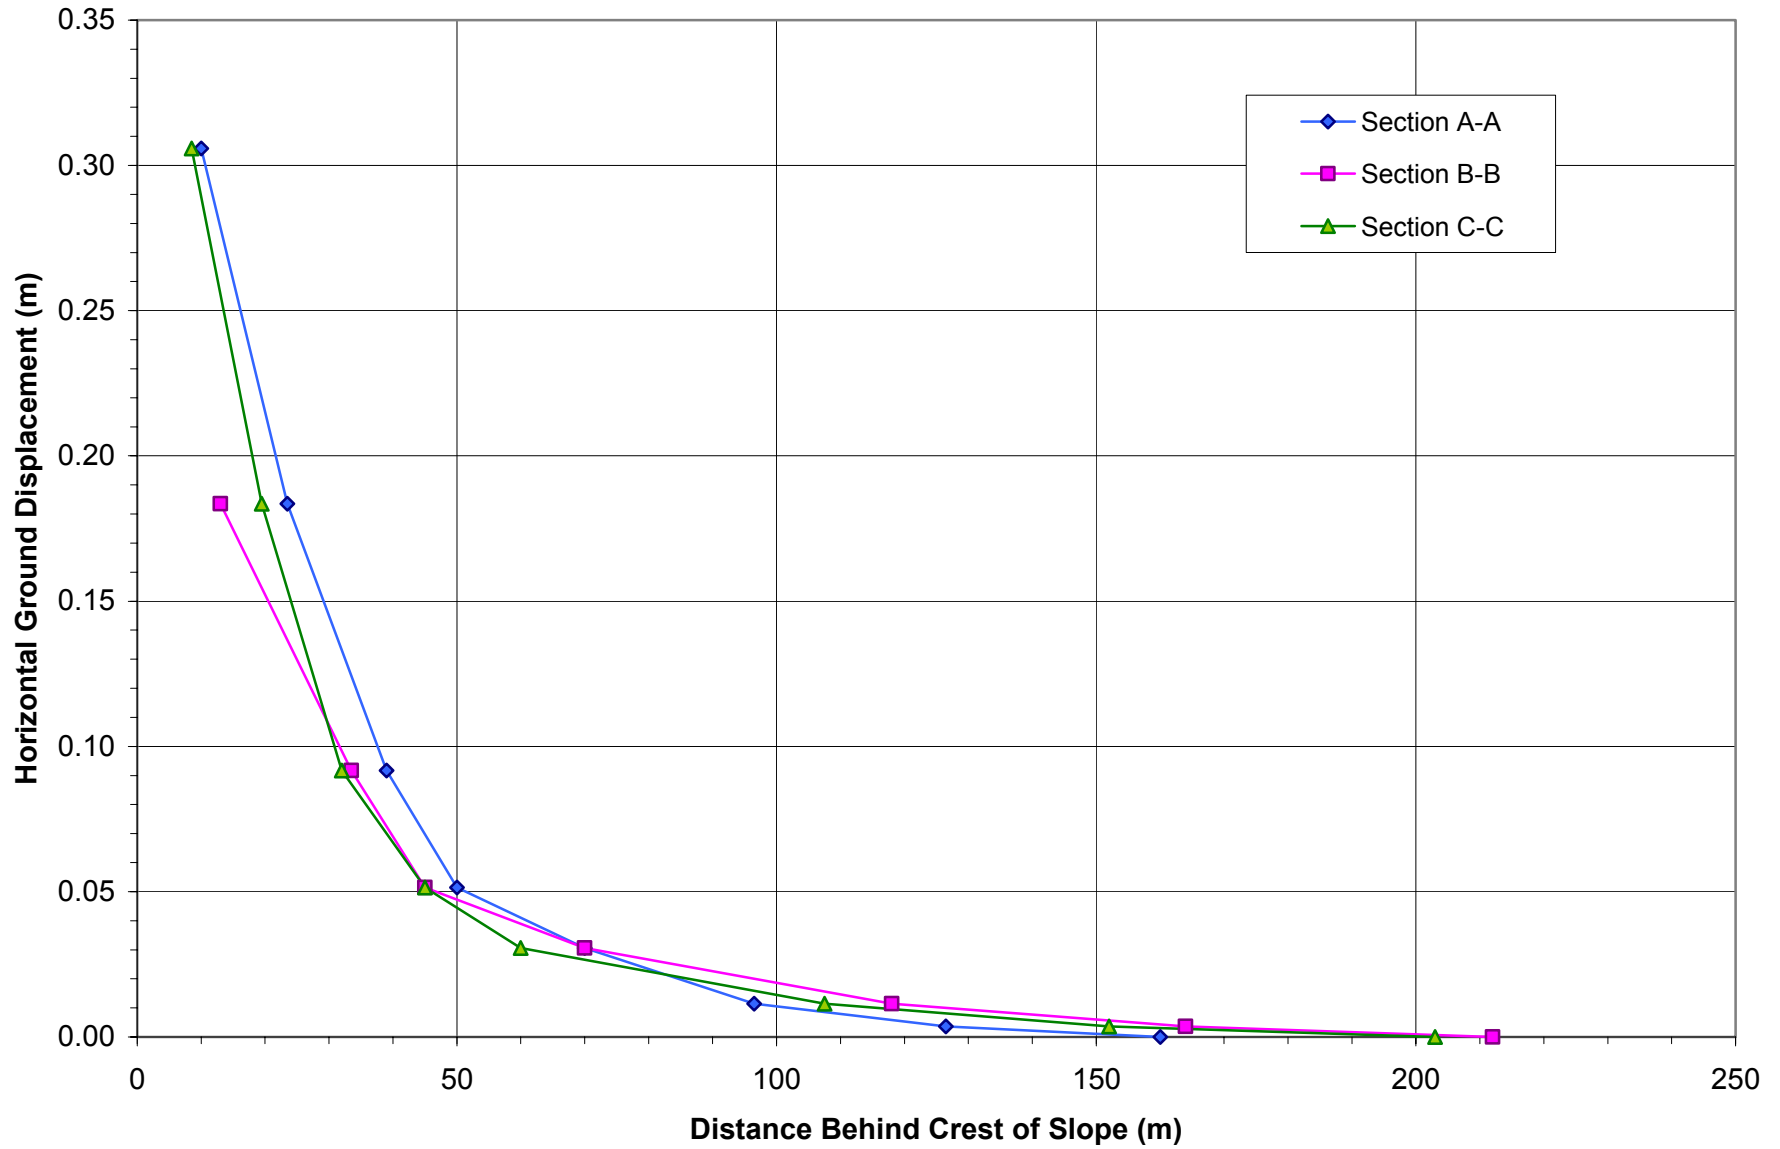
**Horizontal Ground Displacement vs Distance  
475-Year Seismic Event**

The threshold displacement at which straining would reduce the soil strength sufficiently to cause a general slope failure requires further field and laboratory investigation, and cannot be determined from the available information. Given the relatively low static safety factors, we believe that horizontal displacements of 50 mm or more may be sufficient to present a high risk of slope failures. However, given the lack of data on the strain-softening characteristics of the Haney Clay, the potential for instability should not be ruled out for horizontal displacements as low as 25 mm without more detailed study.

Therefore, based on the displacement vs. distance from crest profiles on Figure 4a, it is conceivable that slope instability could be triggered by the **475-year** seismic event within distances on the order of 80 m back from the crest of the bluffs; within distances of about 50 m from the crest of the bluffs the risk of instability could be qualitatively described as “high”. Based on the displacement vs distance profiles on Figure 4b, there is a “low” risk of a deep-seated failure occurring due to the **100-year** seismic event, although surficial slides could be triggered.
