**GOLDER REPORT TO MINISTRY OF ENVIRONMENT
JULY 1983**

REPORT TO
BRITISH COLUMBIA MINISTRY OF ENVIRONMENT
WATER INVESTIGATION BRANCH
ON
GROUND WATER MONITORING AND
STABILIZATION STUDY
FRASER RIVER NORTH RIVER BANK
MAPLE RIDGE, BRITISH COLUMBIA

July, 1983

822-1071

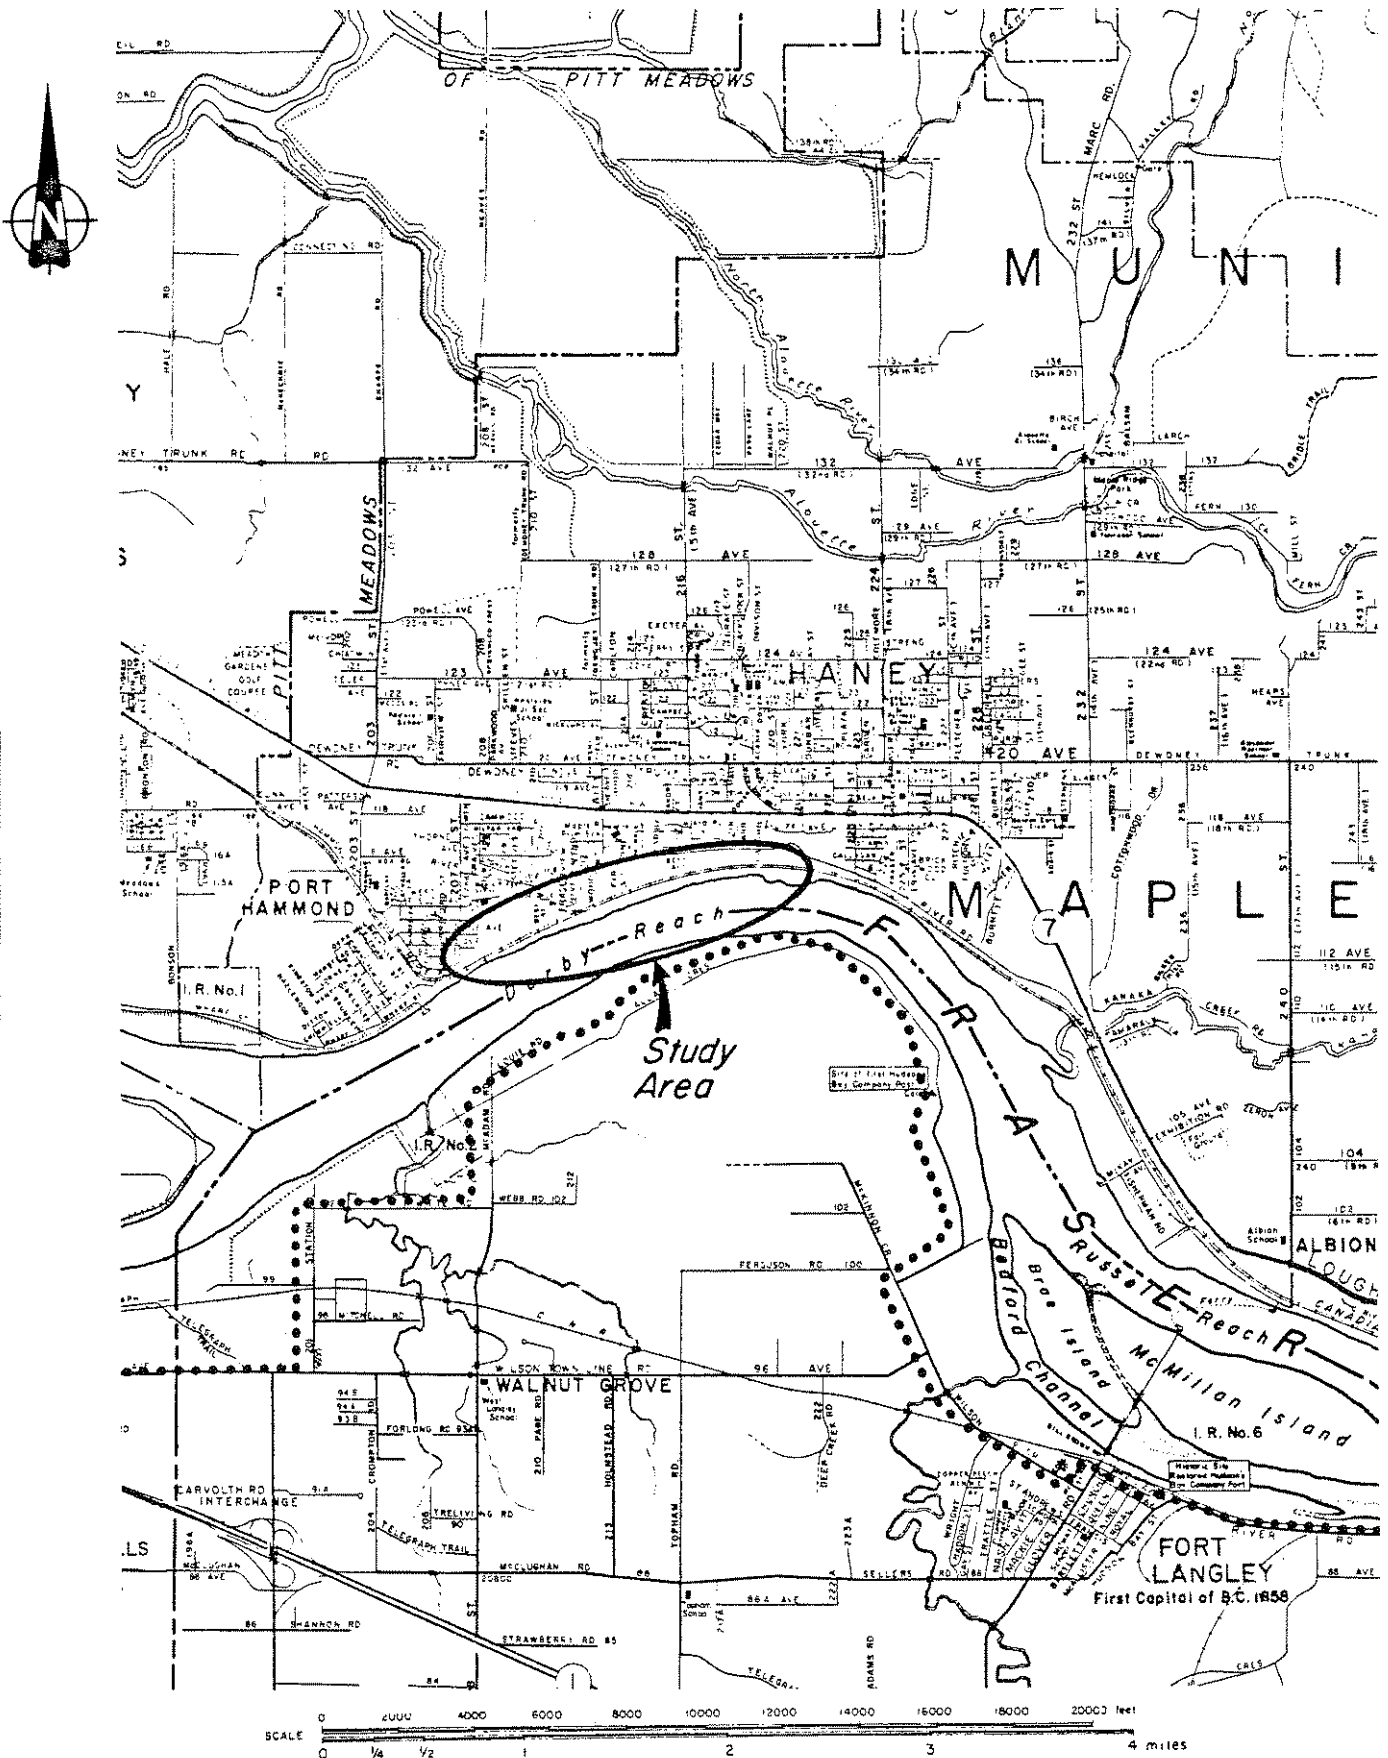
Figure 1

Golder Associates have been retained to carry out a ground water monitoring study in the area adjacent to the Fraser River between Haney and Port Hammond in the District of Maple Ridge, B.C. (see Figure 1). The results of a previous study on the stability of the slopes in this area are presented in our report 782-1179, dated August, 1979.

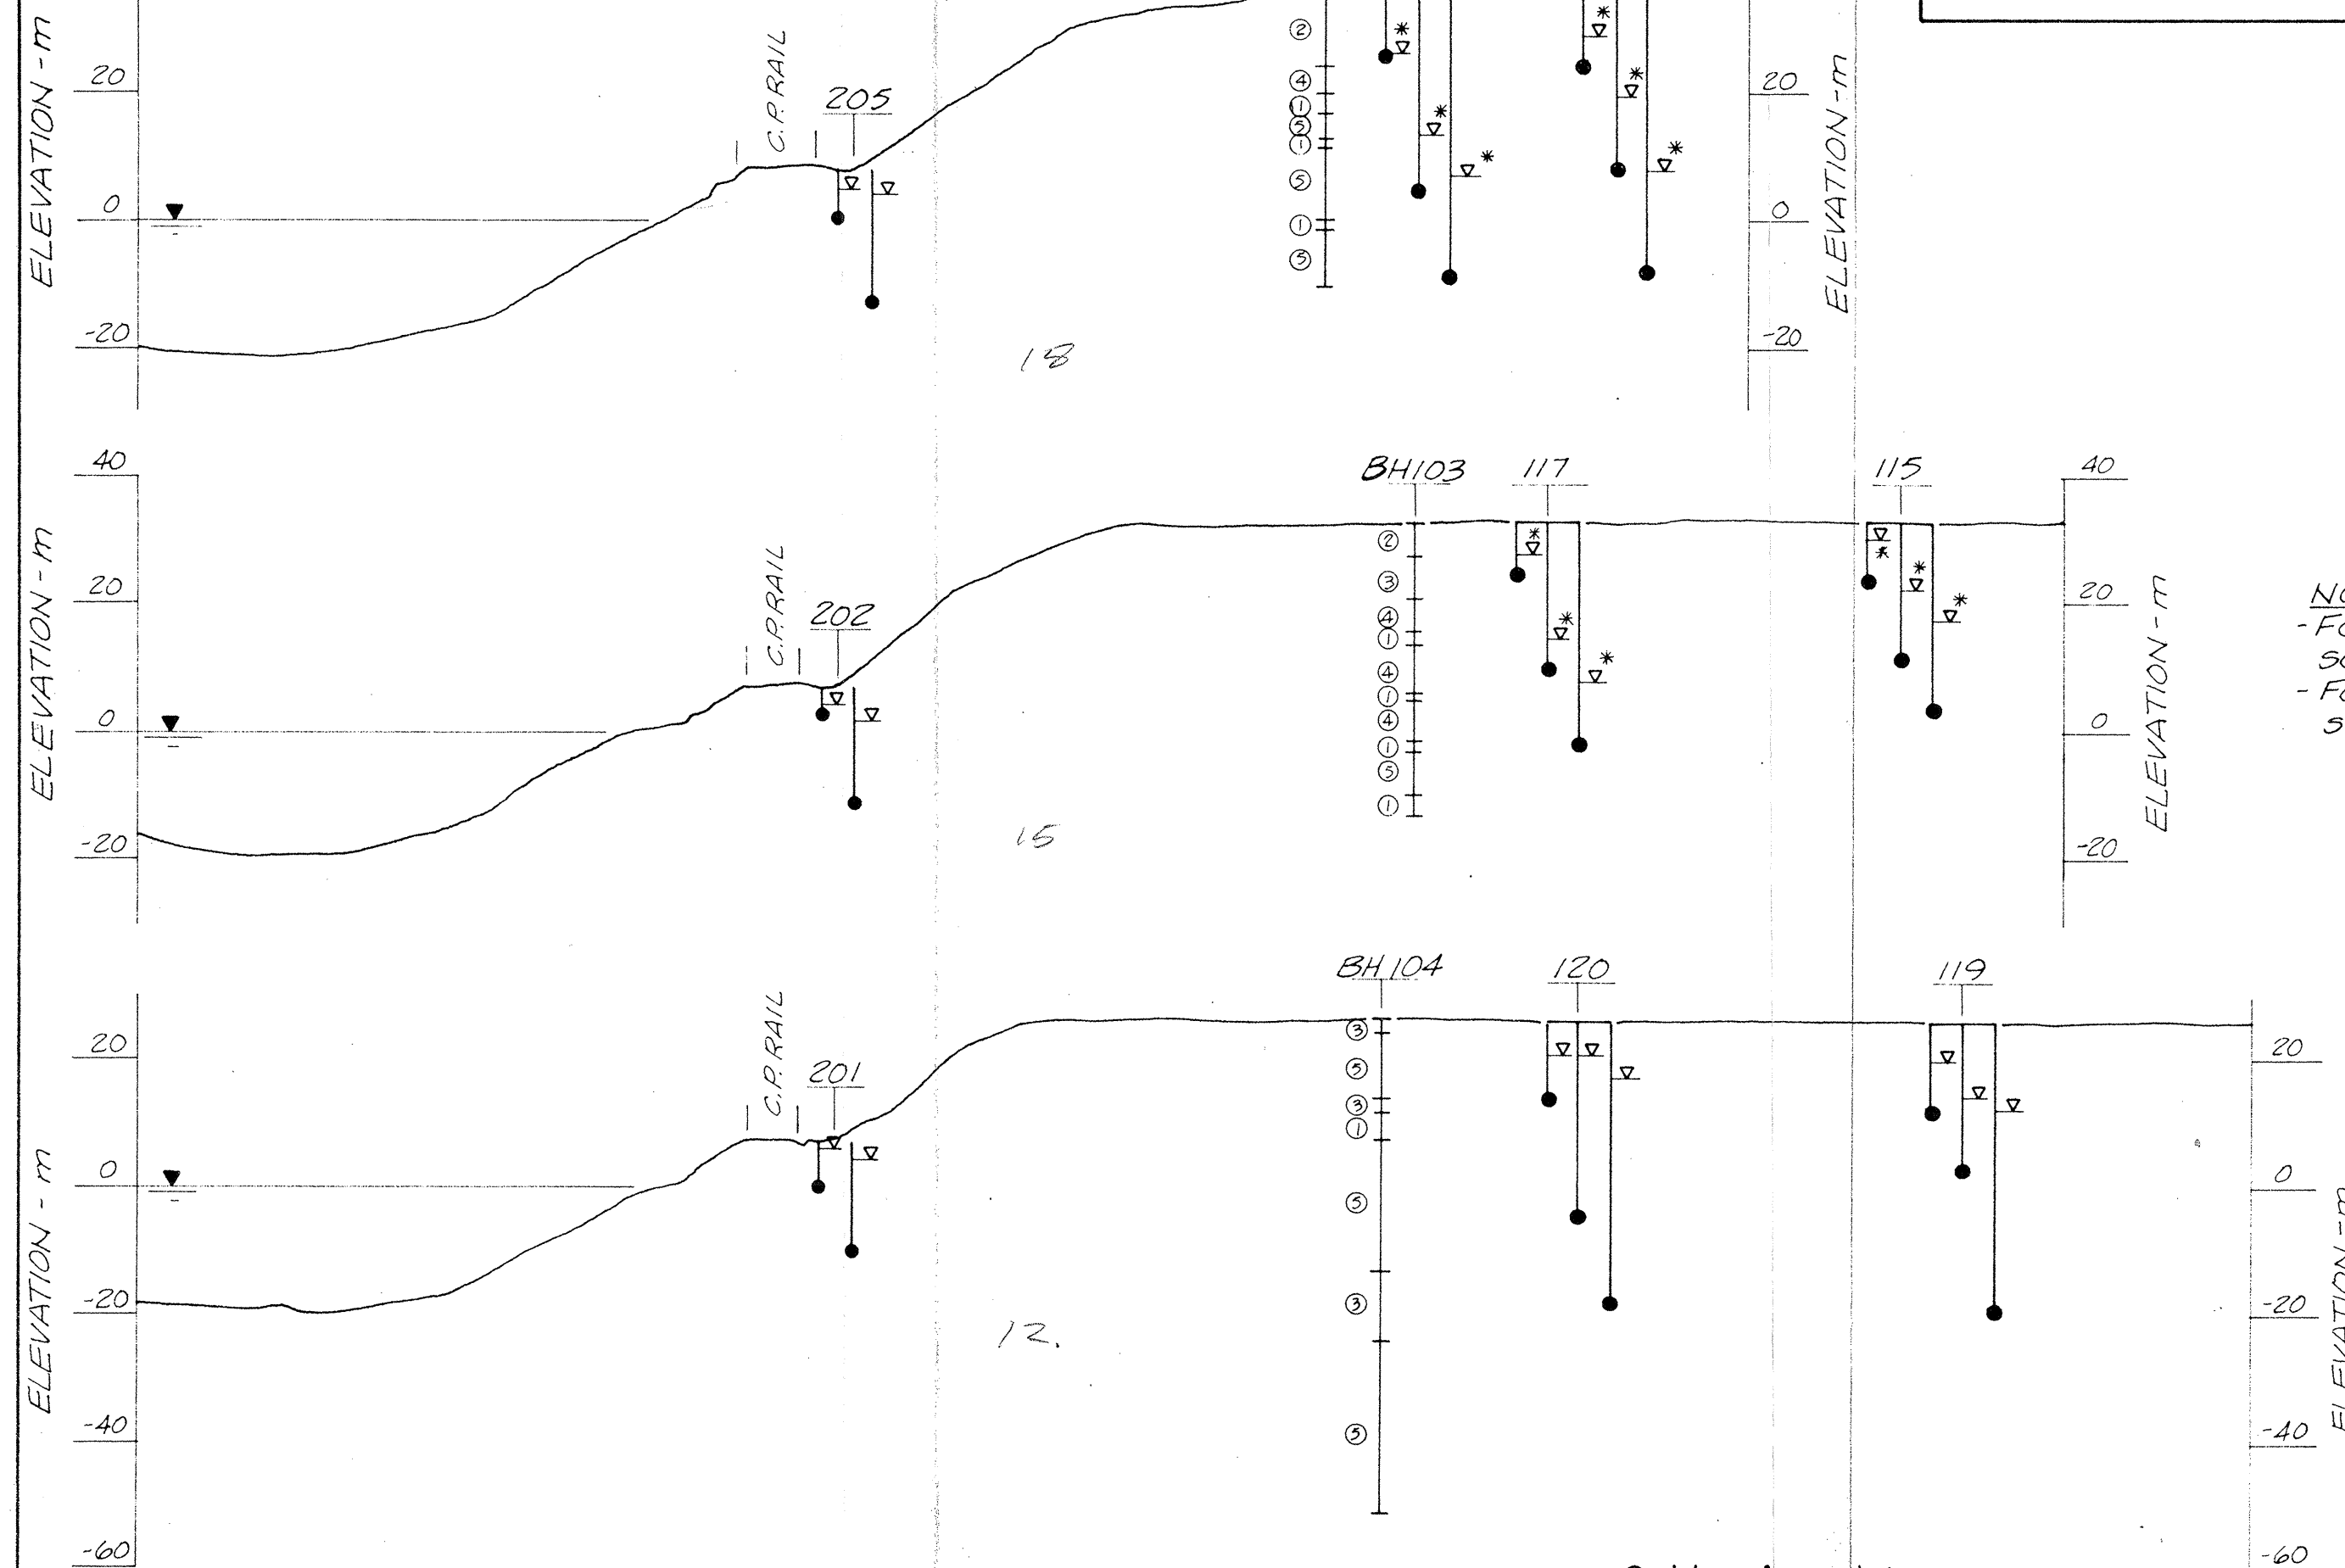
Figure 4

CROSS SECTIONS 12, 15 & 18
SHOWING PIEZOMETER INSTALLATIONS

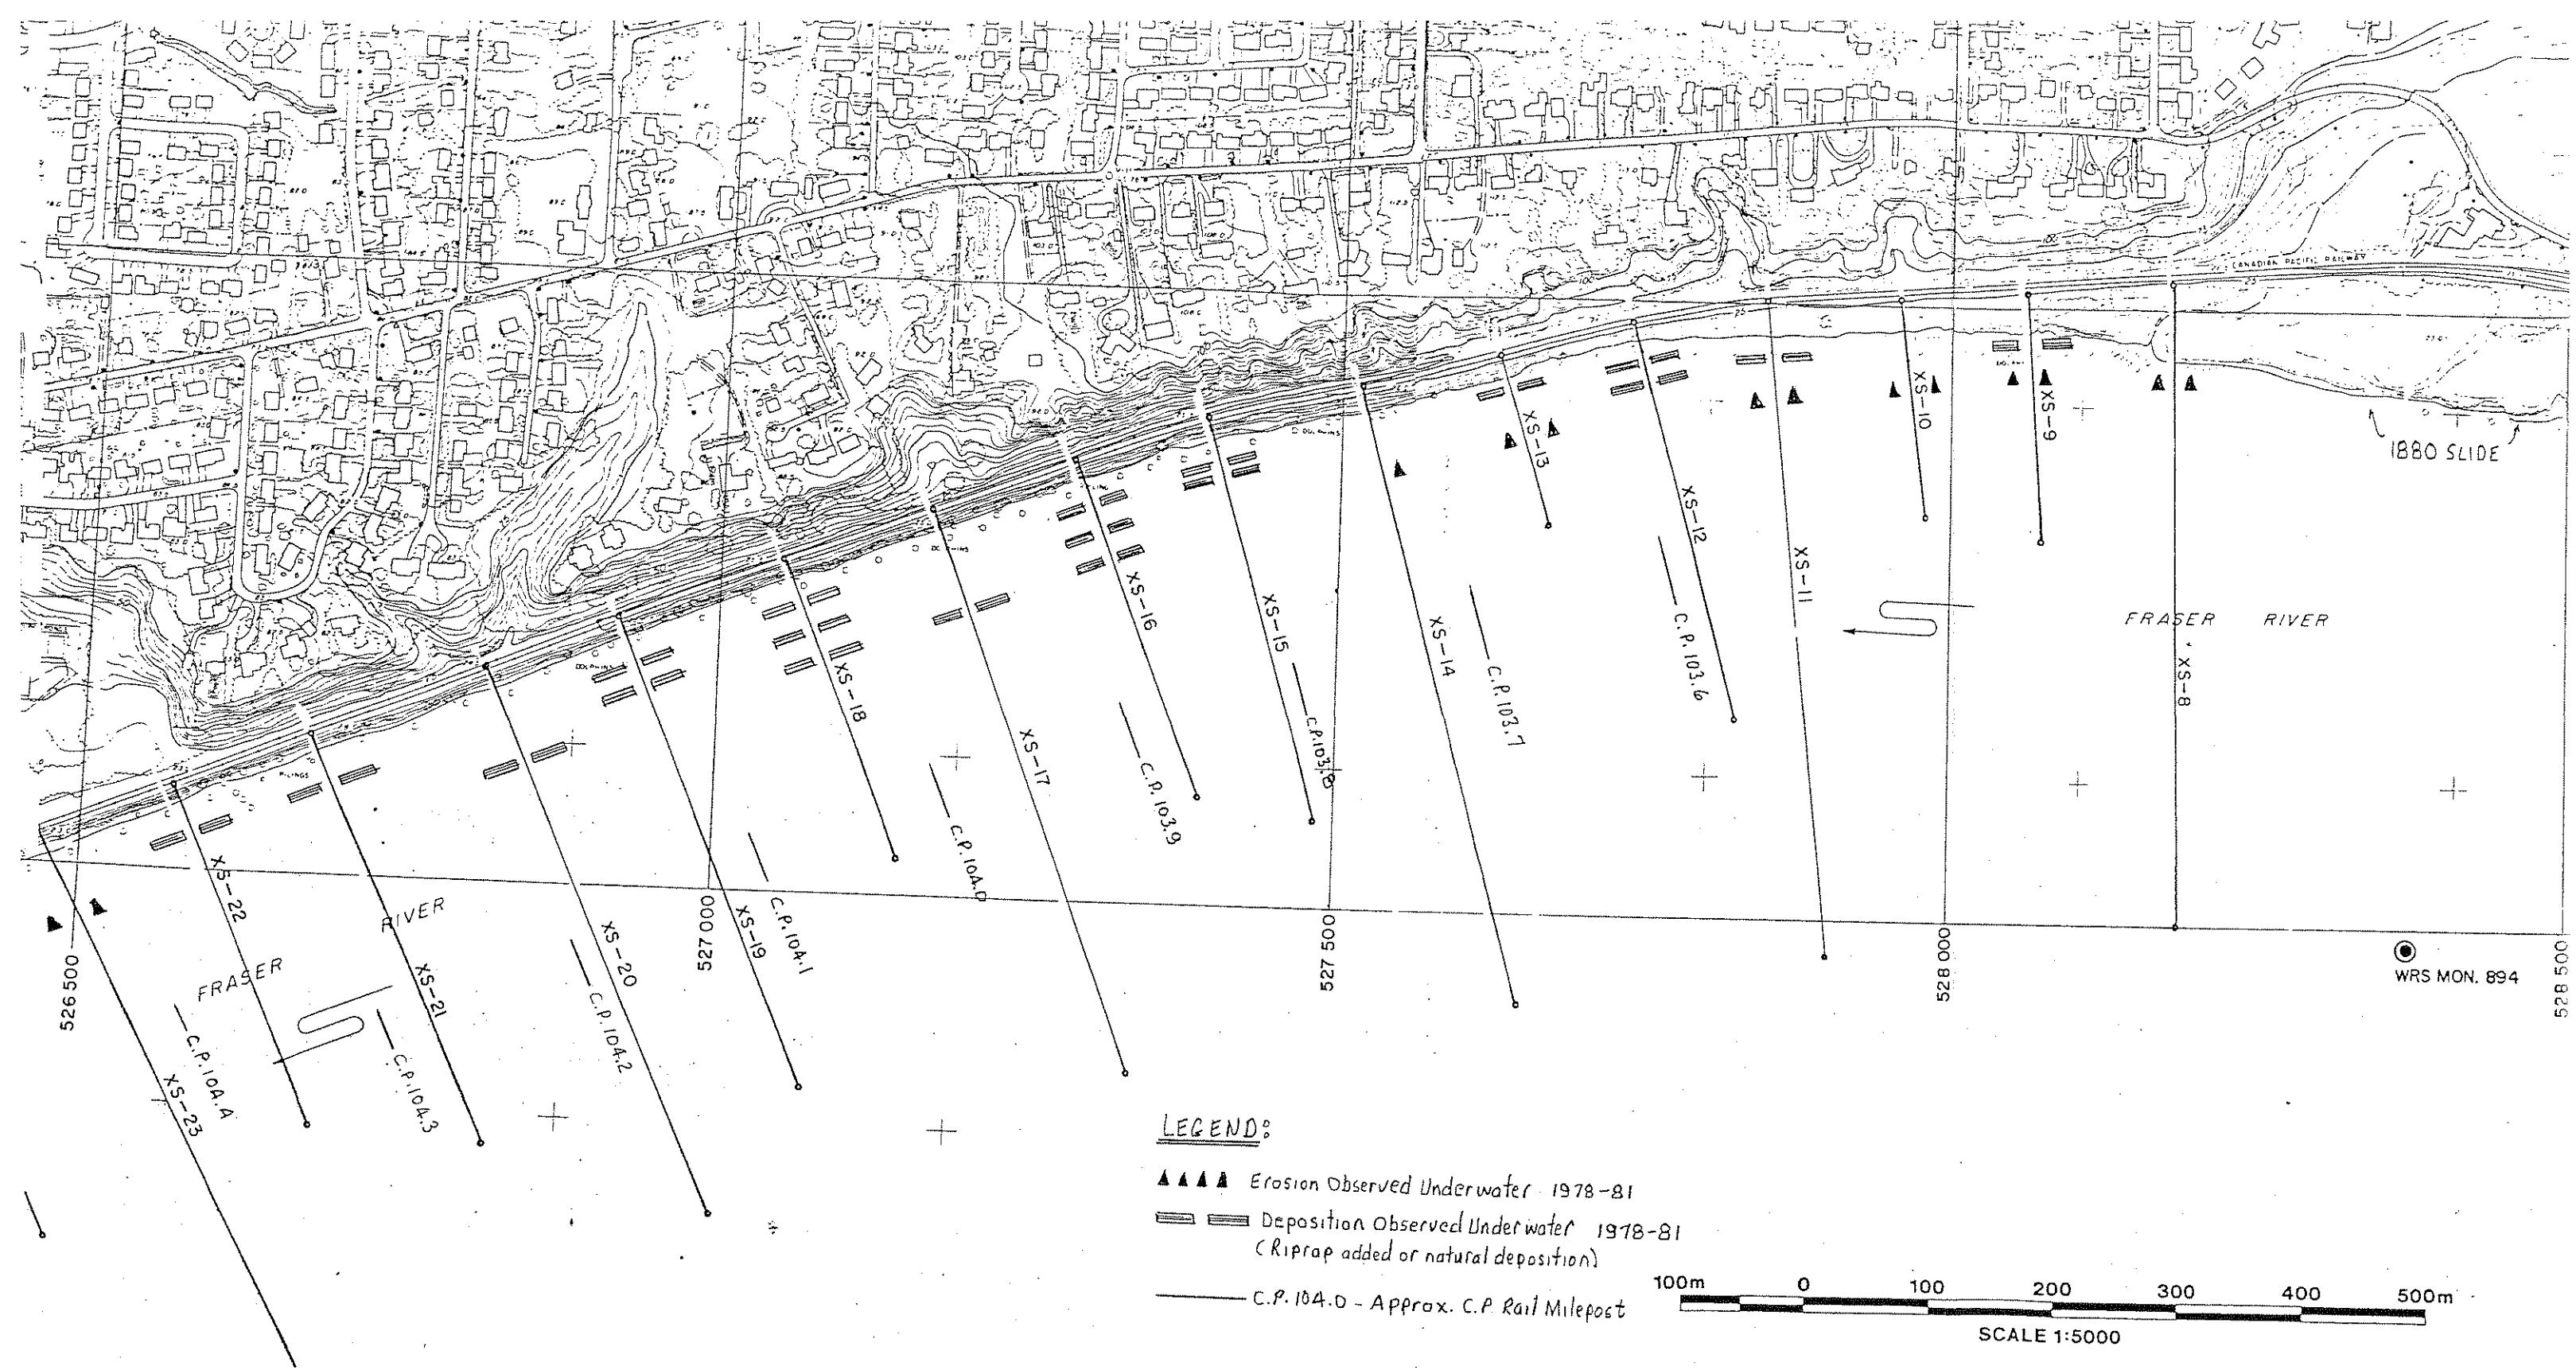
FIGURE 1 PLAN OF CROSS SECTIONS & EROSION/DEPOSITION AREAS

- (2) For the relatively small Fraser floods of 1978 through 1981, riprap placed by C.P. Rail seems to have prevented bank erosion in those areas. However, the 1981 survey does show a few local pockets of considerable erosion (up to 10 metres horizontal movement) at the toe area of the north river bank - near the channel thalweg between Ministry cross sections 8 and 14. Figure 1 summarizes the approximate location of both noted erosion and deposition. This latter term refers to both riprap additions by C.P. Rail and to natural siltation. Erosion as noted, if left unchecked, would lead to future riprap slumping and thus more bank erosion.

- (3) Based on the curvature and plan form of the bend, it is expected that the reach with the highest erosion potential is between cross sections 5 and 19; between the 1978 and 1981 surveys, erosion was observed between Ministry cross sections 6 and 15. There is no reason to expect a decrease in either the potential or observed erosion in the foreseeable future.
